「中越沖地震放射線災害調査」

# 中越沖地震放射線災害調査

Title: Concerns of disaster medical assistance team (DMAT) members about troubles at the nuclear power plant: experience from the Niigata Chuetsu-Oki Earthquake July 16, 2007, in Japan

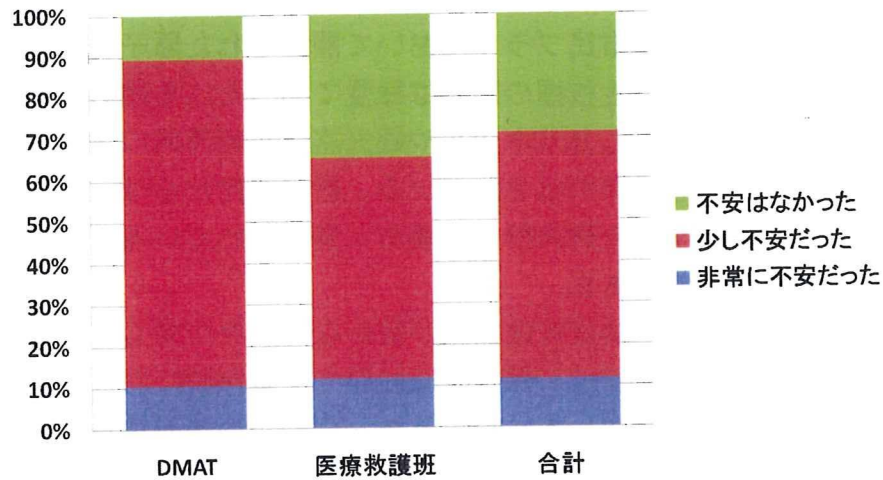
## 図2: 救援者の不安

救援者の不安については、DMAT、救護班へのアンケート調査を行った。被ばくへの不安については、DMATの89%、救護班の66%があったと解答した（図2）。一方、情報提供については、DMATの100%、救護班の93%が不十分であると解答した（図3）。

このように、救護に向かった医療チームは、被ばくの不安を抱えたまま、十分な情報を持たずに活動したことがわかった。また、発災直後から活動していたDMATの方がより不安は多く、情報は不十分であったことも示唆された。

放射線被ばくに対し不安がなかったか？

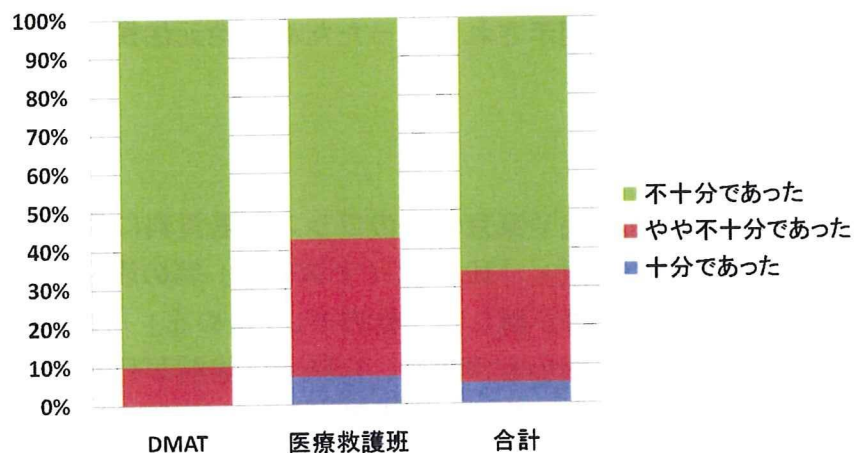
## 図3: 医療チームへの情報提供

放射線災害について医療チームへの情報提供は十分であったか？
