Simplified Evaluation Method of Seismic Resistance for Water Treatment Facilities

Damage to Water Supply Pipelines in the 2011 Great East Japan Earthquake

This paper is focusing on damage to water supply pipelines during the 2011 great east Japan Earthquake. Severe damages were occurred not only to houses and buildings but also lifeline facilities including water supply facilities by this earthquake and tsunami. Water supply pipelines were damaged by strong ground motion and/or soil liquefaction. Outline of the damage is given first. Then the damage analysis is done by using GIS database of water supply pipelines and its damage. Lessons learned regarding the earthquake performance of water supply pipeline are summarized.

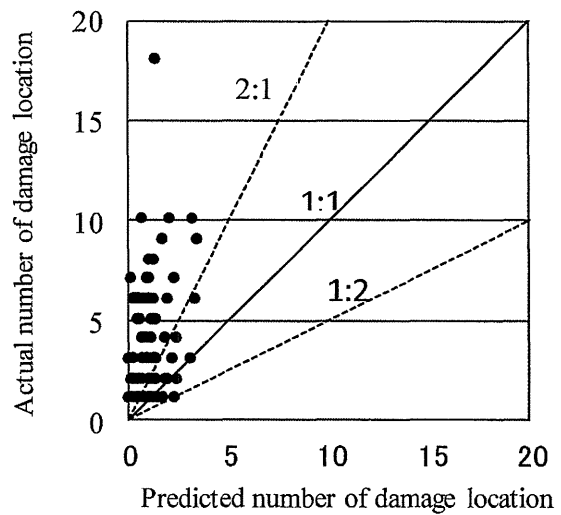
Figure 4 is illustrated the relation between an actual number of damage and predicted one in liquefaction area in Urayasu. The correction factor is 6.0 in spite of microtopography type in the cell in this case. Most of data are plotted at the area above 2.0 of the ration of the actual number of damage to the predicted one. This means that the predicted number of damage is underestimated very much.

The total piping length in Urayasu was 200.93 km and the number of damage was 321, so the damage rate is 1.60 locations/km. The damage rate of pipeline buried in the reclaimed land of Kobe, Ashiya and Nishinomiya in the 1995 Kobe Earthquake was 1.77 locations/km. Peak ground velocity was about 30 cm/s in Urayasu and that in Kobe area in the 1995 Kobe Earthquake was around 100 cm/s. So, peak ground velocity of Urayasu was much smaller than that at Kobe area in the 1995 Kobe Earthquake, but degree of damage was seems to be similar. This means that the effect of liquefaction on pipeline damage may be nearly constant, once it had occurred, and independent of peak ground velocity. Therefore, some modification is necessary in the prediction method in case of liquefaction.

Figure 4 Comparison of actual number of damage with predicted one in Urayasu.

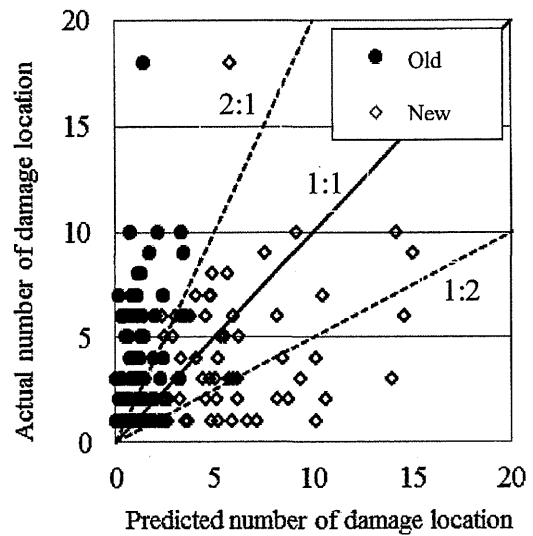
Figure 5 shows the relation between an actual number of damage and predicted one in liquefaction area by using the average damage rate of liquefaction area, in comparison with that using the damage prediction equation in Urayasu. 60.4 % of all data are plotted between two dotted lines and only 14.3% are plotted above 2.0 of the ratio. So, comparison of the predicted number of damage with the actual one shows good agreement.

Figure 5 Comparison of actual number of damage with predicted one by using the average damage rate of liquefaction area in Urayasu.

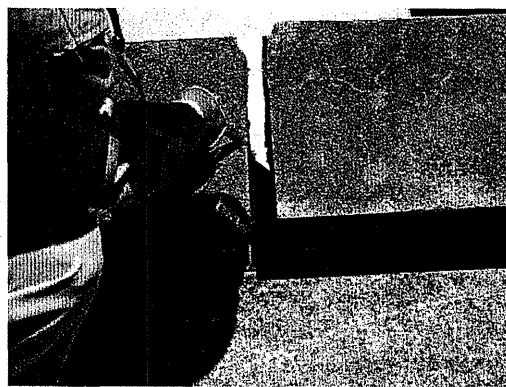
Damage by the Great East Japan Earthquake. Of the five government agencies, four responded to the questionnaire. The result showed there were breakage or fall of plate settlers at some WTPs but there were none but three plants that were forced to suspend water supply for extended periods due to critical damage. Subsequently we made on-site investigations of the three plants (Hebita in Miyagi, Wanigawa in Ibaraki, and Shinjuku in Chiba). The follow-up investigations revealed that the primary cause of the damage was not the ground shaking itself but the ground failure due to liquefaction. Afterwards we examined and found this was also the case in the 1995 Kobe Earthquake as well as subsequent earthquakes: the critical impact on the WTPs was brought about largely by the liquefaction effect, and the other effects played a minor role.

Photo 2. Concrete expansion joint forced widened due to ground deformation (Hebita WTP)

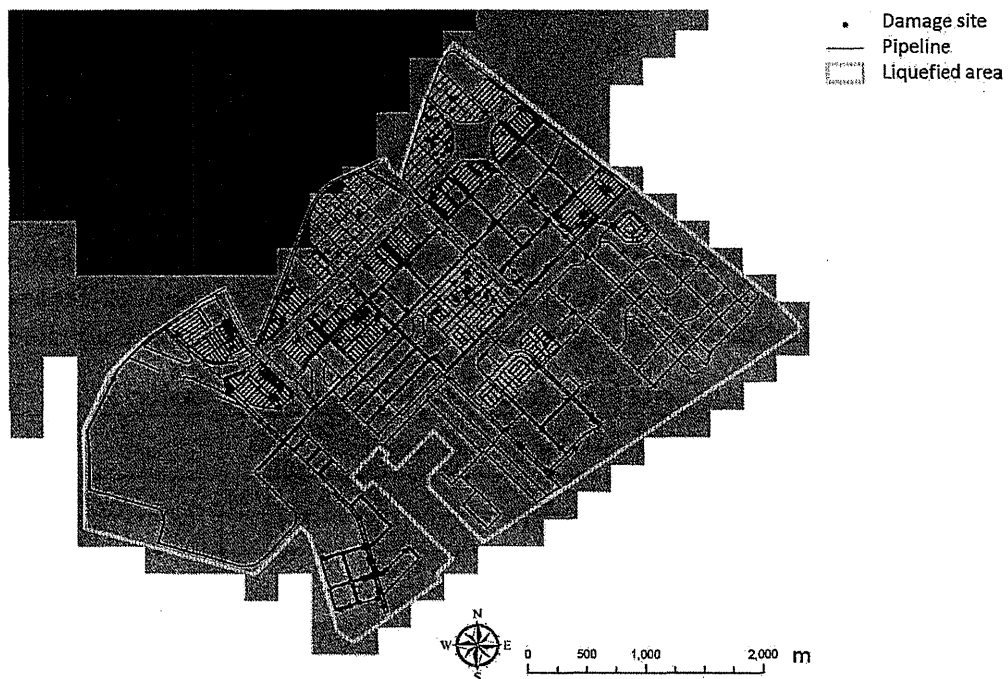
Figure 2 illustrates a water supply pipeline network and sites of damage to buried pipeline in a part of Urayasu City. The area in a yellow line in this figure is a

filled land and severe liquefaction occurred in this area. The total piping length in this area was 200.93 km and the number of damage was 321, so the damage rate is 1.60 cases/km. The damage rate of pipeline buried in the reclaimed land of Kobe, Ashiya and Nishinomiya Cities in the 1995 Kobe Earthquake was 1.77 cases/km. So, degree of damage was seems to be similar. PGV of about 30 cm/s of Urayasu City was, however, much less than that at Kobe area in the 1995 Kobe Earthquake. So, degree of damage was seems to be similar. PGV of about 30 cm/s of Urayasu City was, however, much less than that at Kobe area in the 1995 Kobe Earthquake.

Figure 2. Water supply pipeline network and sites of damage to buried pipeline in a part of Urayasu City.

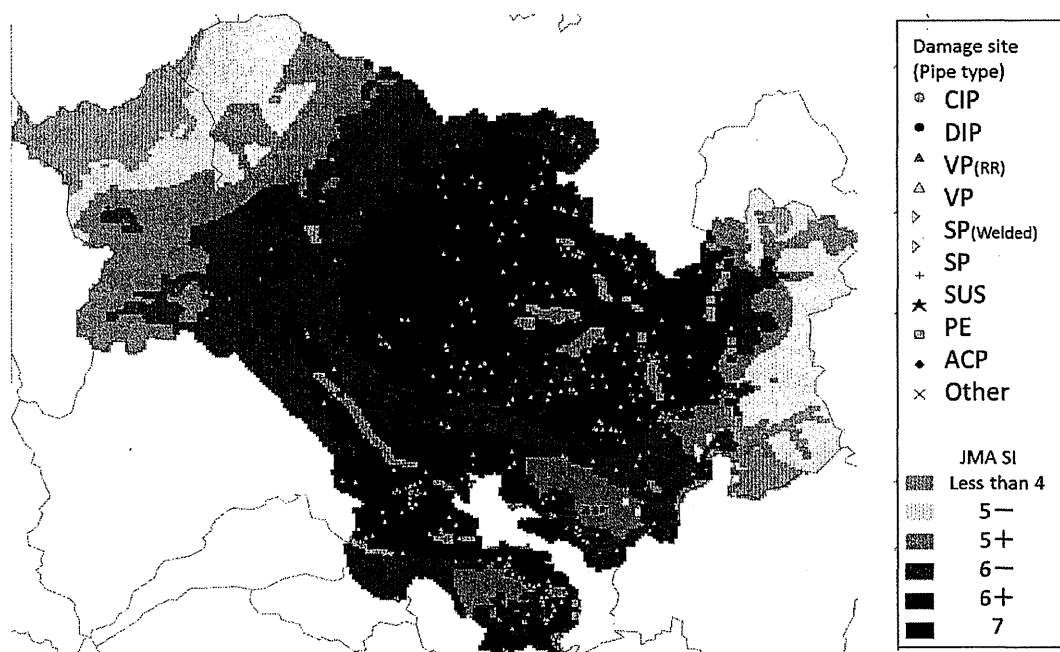
Figure 3. Distribution of JMA seismic intensity estimated by QuakeMap (National Institute of Advanced Industrial Science and Technology) and sites of damage to each pipe type of water supply pipeline.

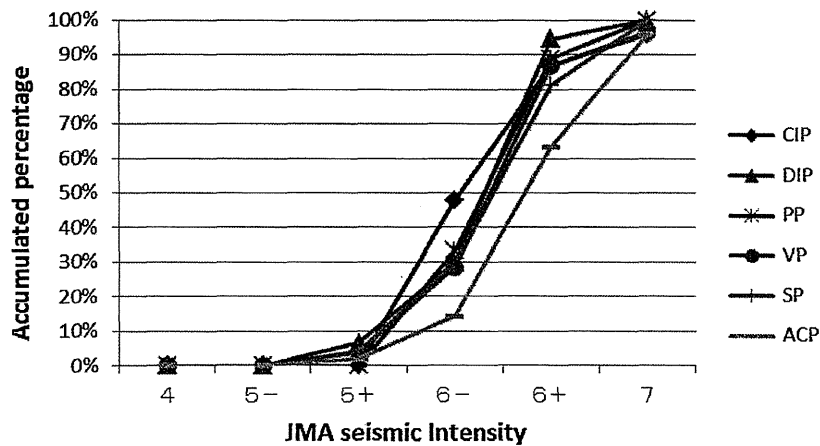
Figure 4 indicates that the damage to pipeline starts to occur at 5+ of JMA seismic intensity and the damage rapidly increases at 6+.

Figure 4. Accumulated damage rate of each pipe type.

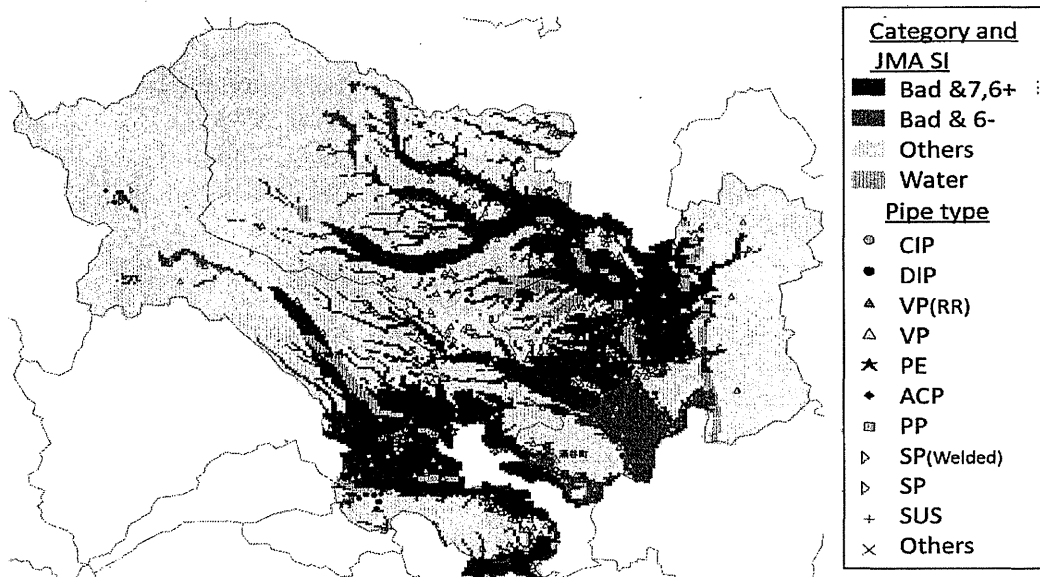
Figure 5. Distribution of ground categories, JMA seismic intensity and the sites of damage to each pipe type.
