地震被害実態に基づく浄水施設簡易耐震診断手法の検討

DAMAGE TO WATER SUPPLY SYSTEM INDUCED BY THE 2011 GREAT EAST JAPAN EARTHQUAKE

Masakatsu MIYAJIMA

Damage Analysis of Water Supply Facilities in the 2011 Great East Japan Earthquake and Tsunami

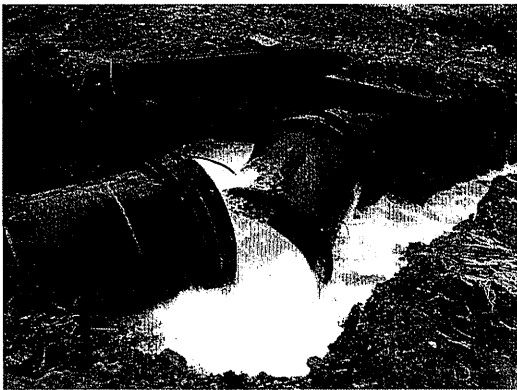
The damage caused by the earthquake and tsunami seems to be classified into five categories. Firstly the causes of damage are divided by earthquake and tsunami. Causes of damage by earthquake are classified into ground shaking itself and ground failure such as liquefaction, slope failure and etc. Photo 1 shows damage to expansion joint of steel pipe with 2400mm diameter. This damage seems to be caused by ground shaking and/or ground deformation. Photo 2 shows an uplift of underground water tank induced by liquefaction.

Photo 1 Damage to steel pipe with 2400mm diameter (Miyagi Pref.)¹⁾.

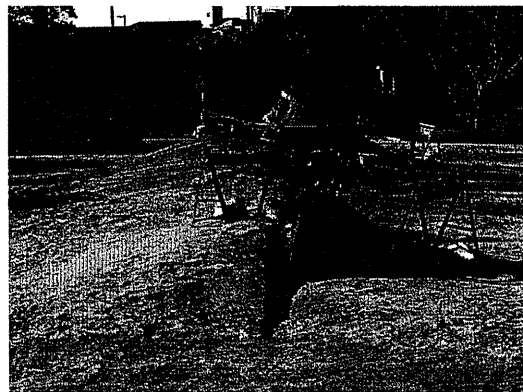
Photo 2 Uplift of underground water tank (Chiba Pref.)²⁾.

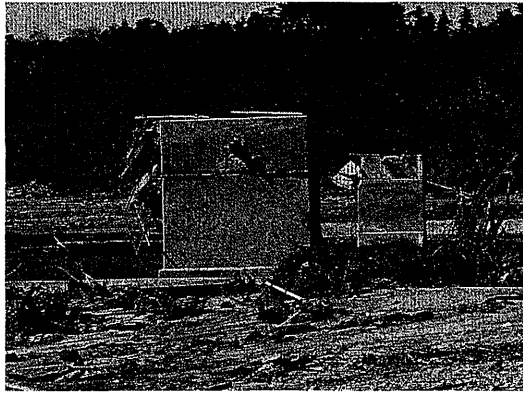
Photo 3 Damage to water pipe bridge
(Miyagi Pref.) .

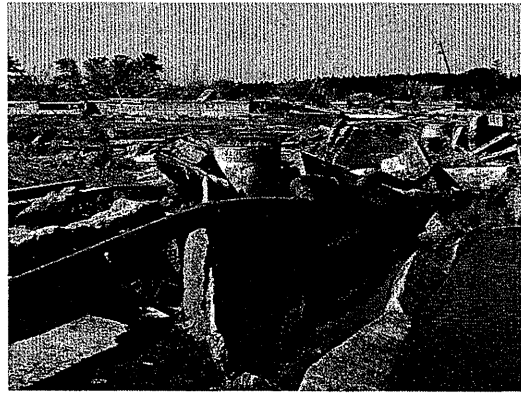
Causes of damage by tsunami are classified into three categories; inundation, washing away and scouring of surface ground. Some intake facilities were inundated by tsunami and became malfunction for long time because of high density of calcium chloride in water. Photo 3 shows damage to a water pipe bridge by tsunami. The water pipe bridge was completely washed away. Photo 4 shows damage to a buried pipeline. The pipeline appeared above ground after tsunami because of scouring caused by tsunami. The mechanism of damage to pipeline, that is, how much force acts on a pipeline is not sure. The mechanism of this kind of damage must be clarified in future.

Photo 4 Damage to pipe by scouring
of tsunami (Miyagi Pref.) .

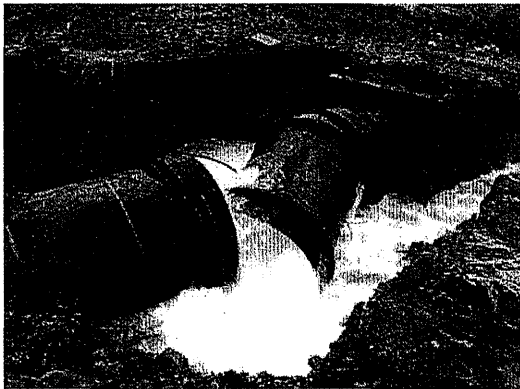
The damage caused by the earthquake and tsunami seems to be classified into five categories. Firstly the causes of damage are divided by earthquake and tsunami. Causes of damage by earthquake are classified into ground shaking itself and ground failure such as liquefaction, slope failure and etc. Photo 1 shows damage to expansion joint of steel pipe with 2400mm diameter. This damage seems to be caused by ground shaking and/or ground deformation. Photo 2 shows an uplift of underground water tank induced by liquefaction.

Photograph 1 Damage to steel pipe with 2400mm diameter (Miyagi Pref.).
(<http://www.pref.miyagi.jp/kigyo/>)

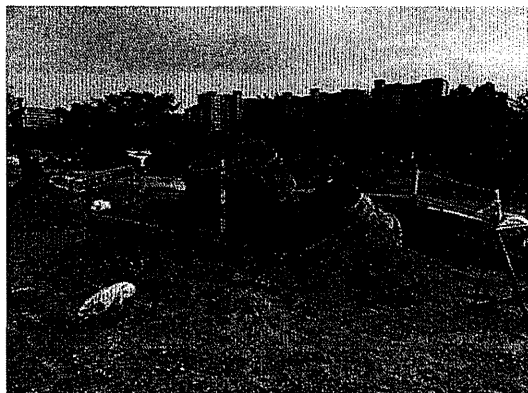
Photograph 2 Uplift of underground water tank (Chiba Pref.).

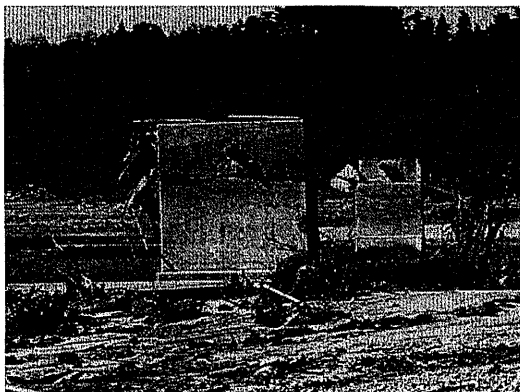
Photograph 3 Damage to water pipe bridge (Miyagi Pref.).

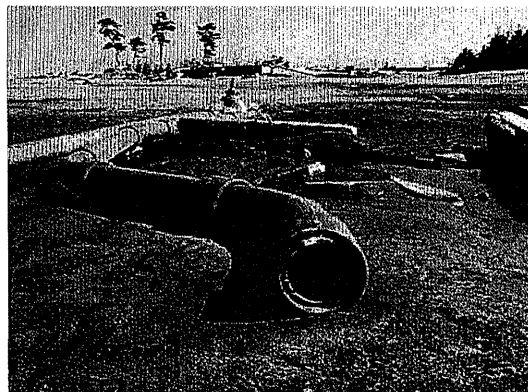
Causes of damage by tsunami are classified into three categories; inundation, washing away and scouring of surface ground. Some intake facilities were inundated by tsunami and became malfunction for long time because of high density of calcium chloride in water. Photo 3 shows damage to a water pipe bridge by tsunami. The water pipe bridge was completely washed away. Photo 4 shows damage to a buried pipeline. The pipeline appeared above ground after tsunami because of scouring caused by tsunami. The mechanism of damage to pipeline, that is, how much force acts on a pipeline is not sure. The mechanism of this kind of damage must be clarified in the future.

Photograph 4 Damage to pipe by scouring of tsunami (Miyagi Pref.).
