# 2011年東日本大震災における水道施設の 地震被害の特徴

## CHARACTERISTICS OF DAMAGE TO WATER SUPPLY FACILITIES IN THE 2011 GREAT EAST JAPAN EARTHQUAKE

# Damage to Water Supply Facilities during the 2011 Great East Japan Earthquake and Tsunami

Masakatsu Miyajima (School of Environmental Design, Kanazawa University, Japan)

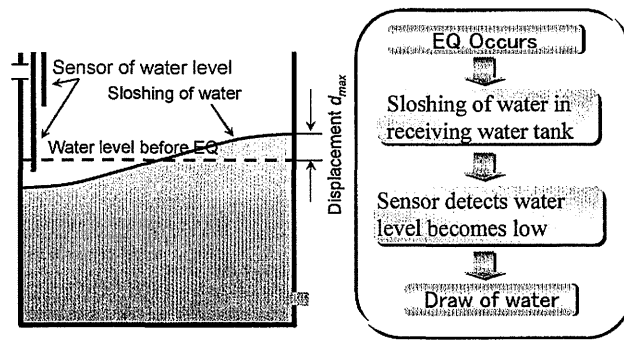
**Figure 8** Mechanism of draw of water from distribution pipe to receiving tank by sloshing during earthquake.

Murata and Miyajima have considered that one of the causes of the unusual phenomena seems to be sloshing of water in receiving water tank. If sloshing of water in receiving water tank is occurred by an earthquake, draw of water to receiving water tank from a distribution pipelines starts by error of a sensor of water level in the receiving water tank as shown in Fig. 8. If sloshing of water in many receiving water tanks occurred simultaneously, an abrupt increase in flow rate and a decrease in water pressure in the distribution pipeline may be occurred. Occurrence of sloshing of water in receiving water tank depends on the dimensions of receiving water tank and the height of water in the tank. Murata and Miyajima have investigated dimensions of receiving water tank in a water distribution block of Osaka City and estimated the natural period of sloshing of the water. Fig. 9 shows cumulative percentage of natural period of water in receiving water tank in case that the height of water is 3/4 and 1/2 of the height of water tank. The height of water is variable and depends on use of water. The natural period of sloshing is more than 1.0 second of more than 80% of the water tank in the direction of long side in the water distribution block in Osaka City. This is one example, but long period ground motion more than one second can be caused sloshing of water in receiving water tank. However, the further study is needed to clarify the cause of an abrupt increase in flow rate and a decrease in water pressure of water distribution system in spite of no damage to pipeline and its effects to emergence response just after large scale disaster.

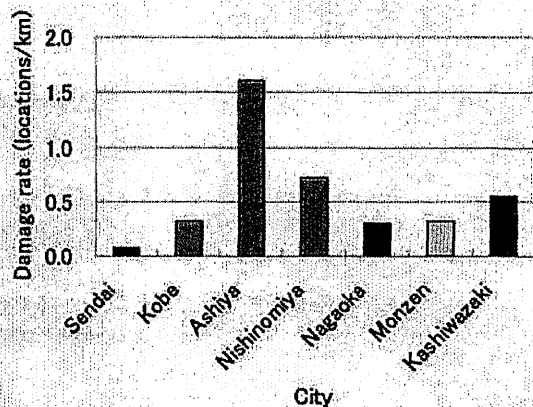
ない。導、送、配水管の被害率は0.07箇所/kmとなる。この被害率を近年の被害地震における他の都市の値と比較すると図1のようになる。図1には1995年兵庫県南部地震における神戸市、芦屋市、西宮市、2004年新潟県中越地震における長岡市、2007年能登半島地震における旧門前町、2007年新潟県中越沖地震における柏崎市の被害率が示されている。それぞれの都市における最大加速度や震度が異なっているので、この図を単純に比較することはできないが、図1によれば、仙台市の導、送、配水管の被害率は、近年の被害地震における他都市の被害率と比較して最も小さい値であることがわかる。

この理由としては、1978年宮城県沖地震以降、幾度かの被害地震に襲われ、耐震化が促進されてきたことが考えられる。仙台市の水道管路の耐震化率は50%を越えており、全国平均(約14%)よりもはるかに高い。しかし、その一方で、海岸付近の比較的軟弱な地域の被害データが、津波浸水地域ということで未だ含まれていないことにも注意を要する。津波浸水地域はより地震断層に近く地震動が大きかった可能性があること、液状化発生の可能性も高いことから、復興事業が進められた際の被害データの収集が極めて重要であると考えられる。

図1 管路被害率の比較

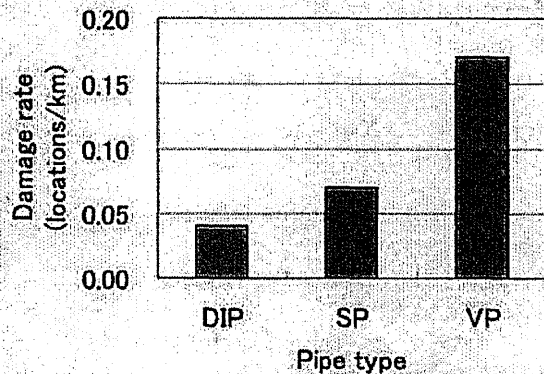
図2は管種別の被害率を、図3は管径別の被害率を示している。これまでの被害地震による被害と同様に、硬質塩化ビニル管の被害率が最も高く、鋼管、ダクタイル鉄管の順で被害率が小さくなっている。また、管径が小さいほど、被害率が大きくなる傾向も、これまでの被害地震と調和的である。

図2 管路被害率と管種との関係

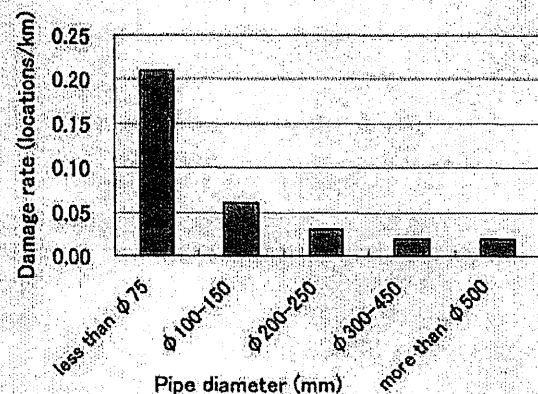
図3 管路被害率と管径との関係

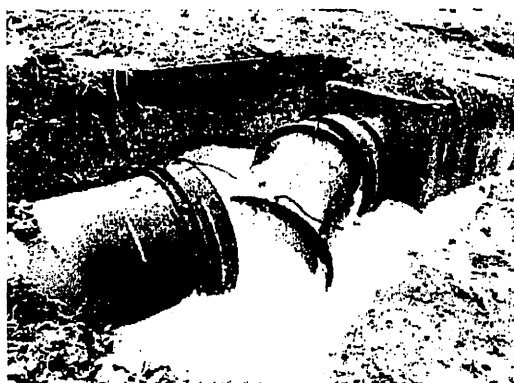
The damage caused by the earthquake and tsunami is classified into five categories. Firstly the causes of damage are divided by earthquake and tsunami. Causes of damage by earthquake are classified into ground shaking, itself and ground failure such as liquefaction, slope failure and etc. Photo 1 shows damage to expansion joint of steel pipe with 2400mm diameter. This damage seems to be caused by ground shaking and/or ground deformation. Photo 2 shows an uplift of underground water tank induced by liquefaction.

Photo 1 Damage to steel pipe with 2400mm diameter (Miyagi Pref.)<sup>6)</sup>.

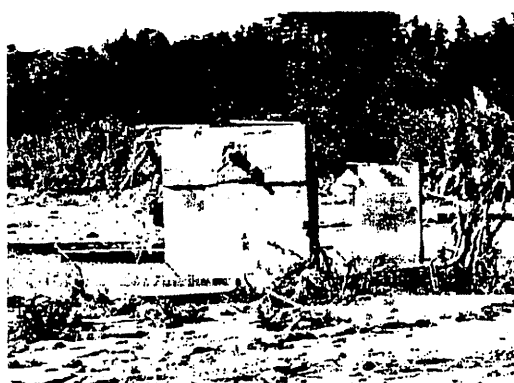
Photo 3 Damage to water pipe bridge (Miyagi Pref.).

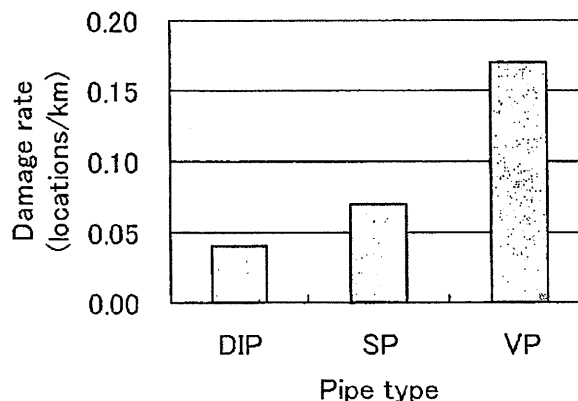
The total number of damage to transmission main, distribution main and branch pipelines was 264 except the flooded areas, and the piping length is 3,761km. The damage rate of transmission main, distribution main and branch pipelines was, therefore, 0.07 (locations/km) The damage rate in relation to pipe type and pipe diameter is shown in Figures 6 and 7, respectively. Figure 6 indicates that the damage rate of polyvinyl chloride pipe (VP) is high. Figure 7 reveals that the smaller the pipe diameter is, the higher the damage rate.

Figure 6 Damage rate related to pipe type.

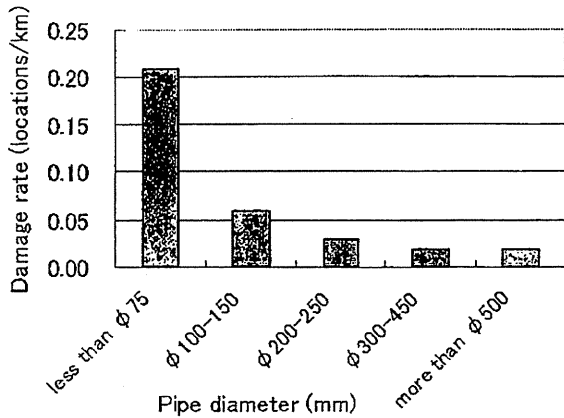
Figure 7 Damage rate related to pipe diameter.

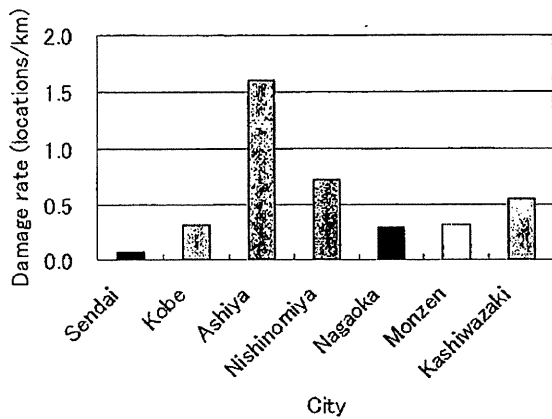
Figure 8 illustrates a comparison of damage rate of Sendai City with those of other cities suffered damage to pipeline in the past earthquakes. Kobe, Ashiya and Nishinomiya Cities suffered damage to water supply pipeline in the 1995 Hyogo-ken Nambu Earthquake, Nagaoka City in the 2004 Niigata-ken Chuetsu Earthquake, Monzen Town in the 2007 Noto-hanto Earthquake and Kashiwazaki City in the 2007 Niigata-ken Chuetsu-oki Earthquake, respectively. This figure reveals that the damage rate of Sendai City was very low in comparison with another cities. Magnitude of earthquake and seismic intensity in each city was different. PGA of K-NET Sendai observation station was, however, not small; 1,808 (cm/c/c) according to Table1. This value is

higher than most of cities listed in Figure 8. One of reasons of low damage rate in Sendai City seems to be high earthquake-proofing rate. The earthquake-proofing rate is defined as the piping length of ductile cast iron pipe with earthquake resistant joint and welded steel pipe divided by the total piping length. The earthquake-proofing rate of Sendai City is 51.2%.

Figure 8 Comparison of damage rate.

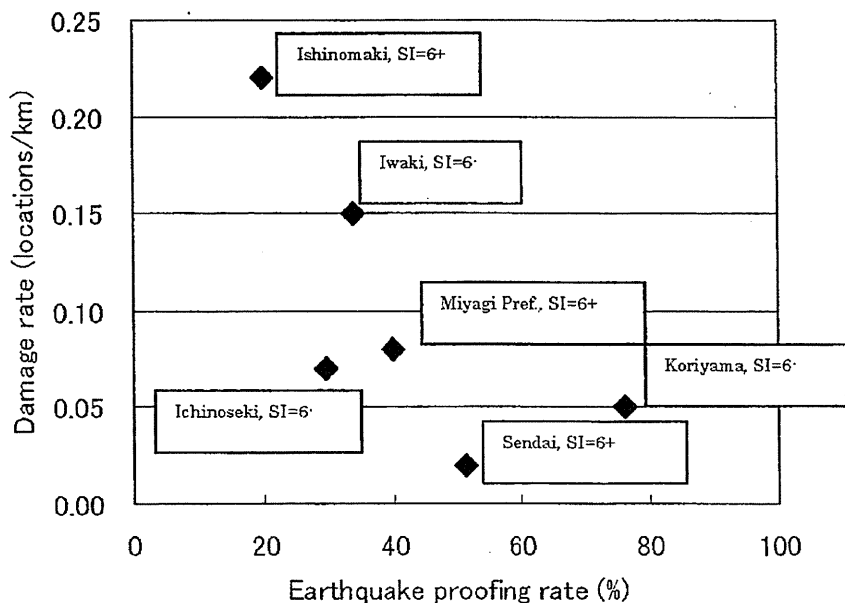
Figure 9 illustrates the relation between the earthquake-proofing rate and damage rate suffered damage in the 2011 great east Japan earthquake. The damage rate shown in this figure is calculated by using the damage to transmission and distribution main pipeline, that is, distribution branch pipeline is not included. This figure indicates that the higher the earthquake-proofing rate, the lower the damage rate is. There was no damage to the ductile cast iron pipe with earthquake resistant joint and welded steel pipe. Effect of earthquake-proofing pipe was, therefore, verified by the earthquake.

Figure 9 Relation between earthquake proofing rate and damage rate.
