Lessons from the 2011 Great East Japan Earthquake and Tsunami Disasters

M. Miyajima*

This paper deals with an outline of damage induced by the 2011 great east Japan earthquake and tsunami. An earthquake with a magnitude of 9.0 occurred off the coast of northeast Japan on March 11, 2011 at 14:46 on local time. The earthquake generated a tsunami of unprecedented height and special extent along the coast of the main island of Japan. The earthquake and tsunami caused about 20,000 deaths and missing and injured about 6,000 people. A suspension of water supply was also occurred at about 2,300,000 houses in east Japan just after the earthquake. An outline of damage to water supply facilities is given and lessons learned from the earthquake and tsunami is discussed.

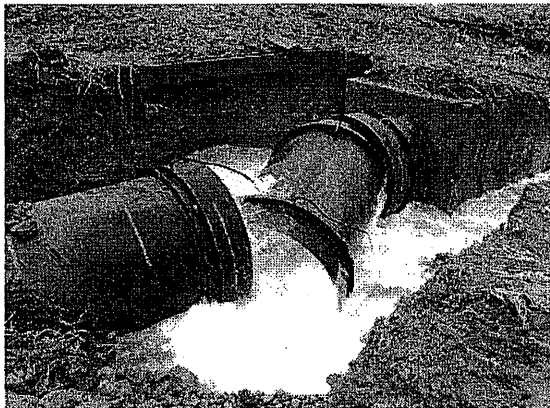
Photo 1 Damage to steel pipe with 2400mm diameter (Miyagi Pref.)⁶⁾.

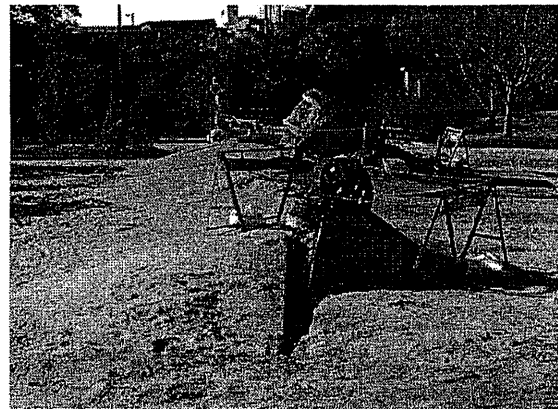
The damage caused by the earthquake and tsunami is classified into five categories. Firstly the causes of damage are divided by earthquake and tsunami. Causes of damage by earthquake are classified into ground shaking, itself and ground failure such as liquefaction, slope failure and etc. Photo 1 shows damage to expansion joint of steel pipe with 2400mm diameter. This damage seems to be caused by ground shaking and/or ground deformation. Photo 2 shows an uplift of underground water tank induced by liquefaction.

Photo 2 Uplift of underground water tank (Chiba Pref.)⁷⁾.

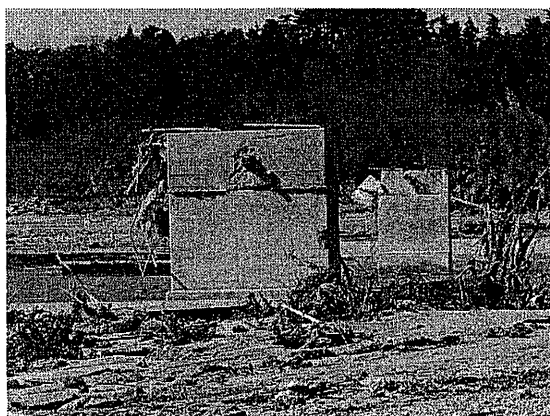
Photo 3 Damage to water pipe bridge (Miyagi Pref.).

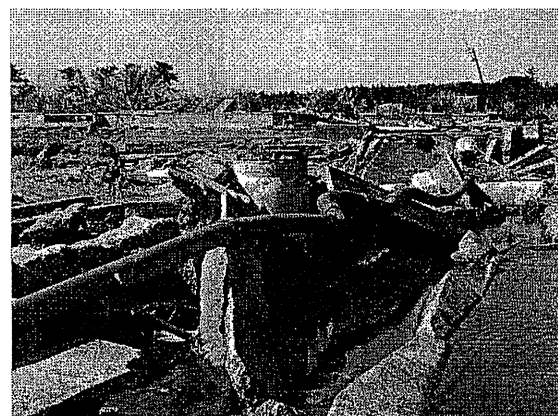
Causes of damage by tsunami are classified into three categories; inundation, washing away and scouring of surface ground. Some intake facilities were inundated by tsunami and became malfunction for long time because of high density of calcium chloride in water. Photo 3 shows damage to water pipe bridge by tsunami. The water pipe bridge was completely washed away. Photo 4 shows damage to pipeline. The pipe appeared above ground after tsunami because of scouring caused by tsunami. The mechanism of damage to pipe, that is, how much force acts on a pipe is not sure. The mechanism of this kind of damage must be clarified in future.

Photo 4 Damage to pipe by scouring of tsunami (Miyagi Pref.).

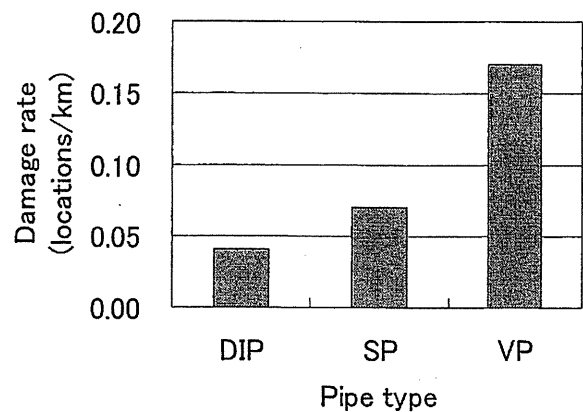
Figure 6 Damage rate related to pipe type.

The total number of damage to transmission main, distribution main and branch pipelines was 264 except the flooded areas, and the piping length is 3,761km. The damage rate of transmission main, distribution main and branch pipelines was, therefore, 0.07 (locations/km). The damage rate in relation to pipe type and pipe diameter is shown in Figures 6 and 7, respectively. Figure 6 indicates that the damage rate of polyvinyl chloride pipe (VP) is high. Figure 7 reveals that the smaller the pipe diameter is, the higher the damage rate.

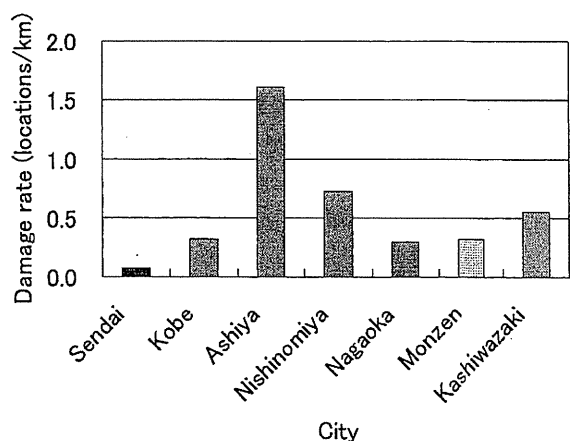
Figure 8 Comparison of damage rate.

Figure 8 illustrates a comparison of damage rate of Sendai City with those of other cities suffered damage to pipeline in the past earthquakes. Kobe, Ashiya and Nishinomiya Cities suffered damage to water supply pipeline in the 1995 Hyogo-ken Nambu Earthquake, Nagaoka City in the 2004 Niigata-ken Chuetsu Earthquake, Monzen Town in the 2007 Noto-hanto Earthquake and Kashiwazaki City in the 2007 Niigata-ken Chuetsu-oki Earthquake, respectively. This figure reveals that the damage rate of Sendai City was very low in

comparison with another cities. Magnitude of earthquake and seismic intensity in each city was different. PGA of K-NET Sendai observation station was, however, not small; 1,808 (cm/c/c) according to Table1. This value is higher than most of cities listed in Figure 8. One of reasons of low damage rate in Sendai City seems to be high earthquake-proofing rate. The earthquake-proofing rate is defined as the piping length of ductile cast iron pipe with earthquake resistant joint and welded steel pipe divided by the total piping length. The earthquake-proofing rate of Sendai City is 51.2%.

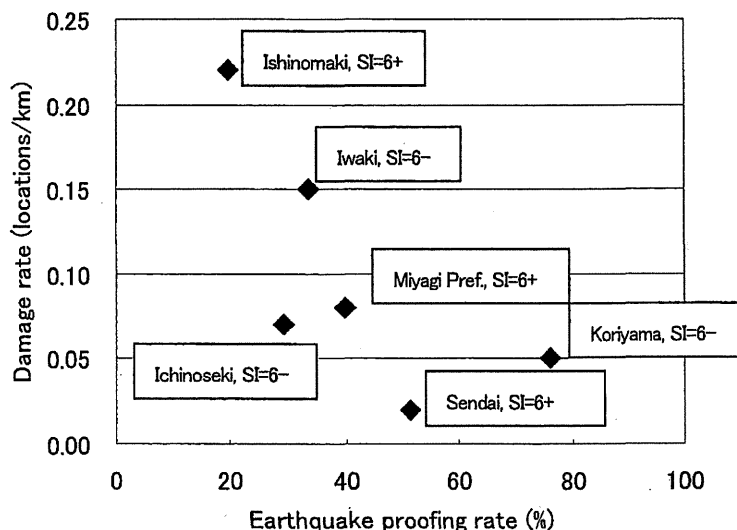
Figure 9 Relation between earthquake proofing rate and damage rate.

Figure 9 illustrates the relation between the earthquake-proofing rate and damage rate suffered damage in the 2011 great east Japan earthquake. The damage rate shown in this figure is calculated by using the damage to transmission and distribution main pipeline, that is, distribution branch pipeline is not included. This figure indicates that the higher the earthquake-proofing rate, the lower the damage rate is. There was no damage to the ductile cast iron pipe with earthquake resistant joint and welded steel pipe. Effect of earthquake-proofing pipe was, therefore, verified by the earthquake.

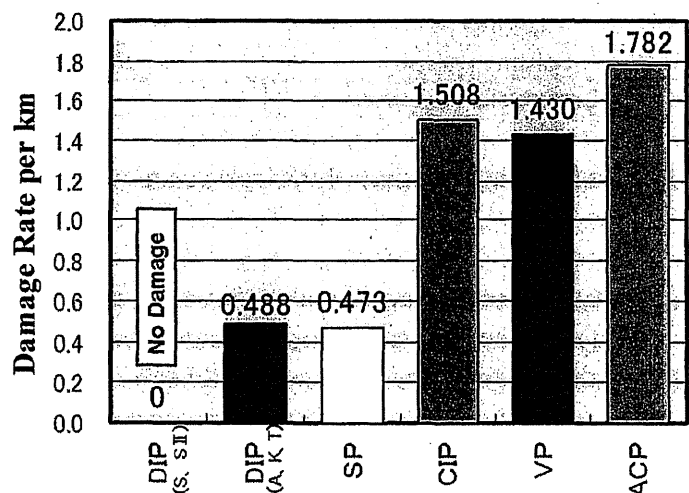
Fig. 3: Pipe damage from 1995 Hyougoken-Nambu earthquake.
