2.2 Centrifuge Tests and Instrumental Set Up

3.1 Small Scale Full Size Test

INVESTIGATION OF SLOPE FAILURE DURING TRENCH EXCAVATION IN PEAT GROUND

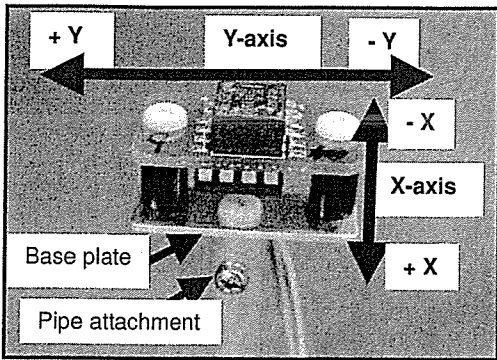
Photo 2. General outline of tilt sensor

vertical and horizontal movement of laser sensors set up the slope top are represented by V_1, V_2 , and H_1, H_2 respectively. Vertical deformation of VDTs is represented by VDT_1, VDT_2 , etc. Tilt sensors were set up both on the slope surface and slope top. They were directly inserted with the tubular pipes attached at the base of the sensor. Tilt sensor placed on the slope surface is represented by A_1, A_2, A_3 , etc. and those on the slope top are represented by A_4, A_5, A_6 , etc. General outline of instrument set up is shown in Figs. 1(a), (b) and (c) and Photo 3. Tilt-sensors were set up near and on the same line of the laser targets.

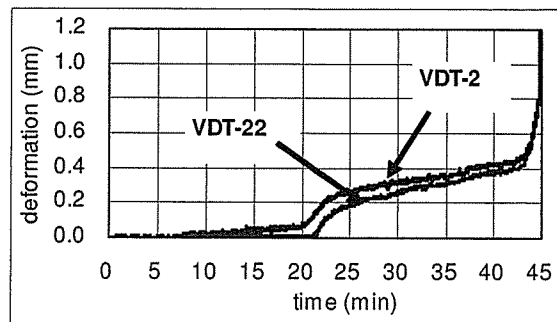
Figure 5(a). Deformation of slope top for Slope-I-2

Figure 5(b). Deformation of slope top for Slope-II-3

Figure 5(c). Deformation of slope top for Slope-IV-1

Figure 5(d). Deformation of slope top for Slope-IV-2

Figure 5(e). Deformation of slope top for Slope-V-1

Figure 5(f). Deformation of slope top for Slope-V-2

In the Figs. 5, deformations measured on the slope top of different small scale full size tests are shown. Here, V and VDT represent the vertical deformation measured by laser sensor and vertical displacement transducers. Digits followed by previous letters represent the distance from the slope crest in centimeter. For Slope-II-3 and Slope-IV-2 and Slope-V-2, deformations measured by VDTs are only shown. Comparing the total time taken for short and large slope heights for same slope angle, it could be observed that the total elapsed time for failure is longer for smaller slope heights than that for longer slope heights. Also, comparing the total elapsed time for failure for both slope heights with slope angles varying from 50 to 70 degrees, it was observed that smaller the slope angle, longer the time for failure. In all the test cases, with the increase in the excavation, gradual increment in the deformation was seen. At the beginning, it was difficult of see the clear increments, but just with the increase in excavation portion and elapsed time, large increment was observed. In all the test cases, laser and VDTs nearer to the slope crest showed the maximum and sharp movement just before the

failure. This shows the possible position for the measurement of slope movement during the excavation in order to predict the failure in advance. Movements of slope surface and slope top during the excavation and just before the failure measured by laser sensors for Slope-I-2, Slope-IV-1 and Slope-V-1 are shown in Figs. 6, 7 and 8, respectively. Bold vertical lines in the figures show the trigger for just before and after the excavation. In all the cases, it could be seen that the movement of S_1 was the maximum as it is in the closest distance from the excavation. Others gradually increase. Sharp increment just before the failure is more prominent in both the places (slope surface and slope top). Measurement of tilt angle either on the slope surface or on the slope top or both for Slope-I-2, Slope-IV-1 and Slope-V-1 are shown in Figs. 9(a), (b), 10 and 11(a), (b), (c). Although movements of each sensor for both X and Y directions were measured, here mainly movements along X direction are shown. At the beginning where small excavations were only made, clear increment in tilt angles was not seen. But after certain elapsed time, gradual increment in tilt angle was seen, which sharply increases just before the failure. Comparing the laser sensors data (including VDTs data) of Figs. 5(a), (c), (e) and Figs. 6, 7, 8 and tilt sensors data of Figs. 9, 10, 11, similar trend of movements were observed. This shows the applicability of possible measurement of slope failure pattern so that prediction of failure could be done in advance. In Fig. 11(c), movement of tilt sensors on the slope top along Y direction for Slope-V-1 is shown. Sharp increment before failure was seen. Therefore, knowing the movement along X and Y directions with tilt sensors, possible direction of failure could also be predicted in advance.

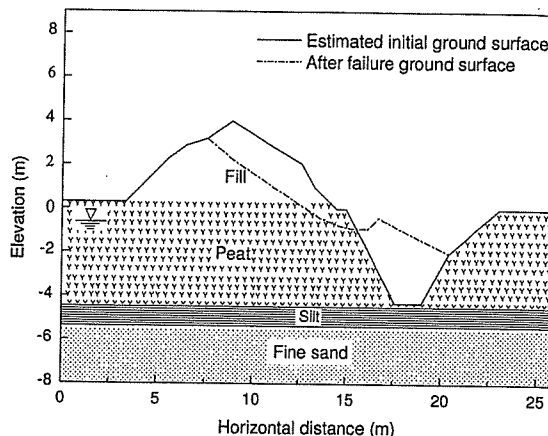
Figure 3. A schematic view of the cross section AA

The slope stability is conventionally analyzed in terms of factor of safety, FS. The factor of safety is defined as the ratio of the available shear strength along the critical failure surface to the shear stress acting on the surface. Because the permeability of peat layer is relatively low, at the end of the excavation the soils will be virtually in the undrained condition and a total stress analysis will be relevant. According to the eyewitness interviews, the day prior to the slope failure, the excavated materials had been dumped and formed an embankment on the top of the slope. By considering the equilibrium of the collapsed ground volume, the initial condition prior to the failure can be estimated as shown in the Figure 3.

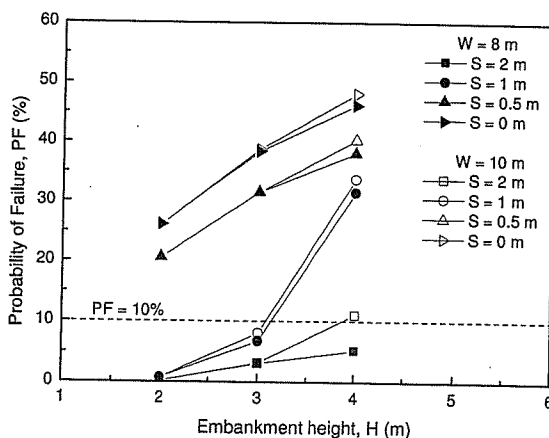
Figure 6. Relationship between PF, S and H

As can be seen in the figure, the probability of failure increases with the embankment height and the probability of failure is higher than the allowable probability of failure ($PF > 10\%$) when the embankment height becomes higher than 3 m with the side clearance of less than 1 m.

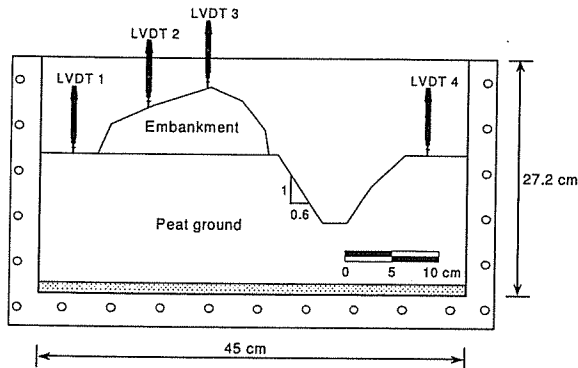
Figure 7. A schematic view of the experimental model

After the mixing, the slurry was placed into the model box and pre-consolidated under a consolidation pressure of about 10 kPa. By this method, relatively high water and organic content and low density can be achieved in the peat ground model which is consistent well with the natural peat ground. The resulting block of the peat ground model was trimmed to form the trench geometry. The embankment of excavated material was prepared in another container by static compaction using the belloram cylinder. The embankment was trimmed to a desired geometry and then placed on the top of the peat ground model. To observe the deformations of the slope during the centrifuge flight, the target markers were embedded into the model at equally space intervals. The sidewall friction of the model box was reduced by lubricating the sidewalls with the silicone grease. Figure 7 shows a schematic view of the experimental model setup

and the arrangement of linear variable displacement transducers (LVDTs). The digital video camera and CCD camera were installed in front of the model box to provide a continuous record of the ground model during the centrifuge test.

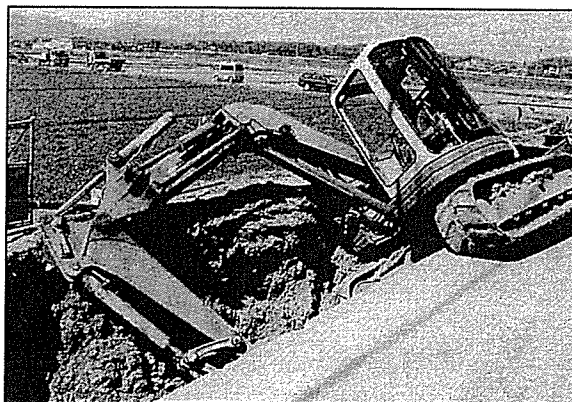
Photograph 1. Ground collapse during trench excavation

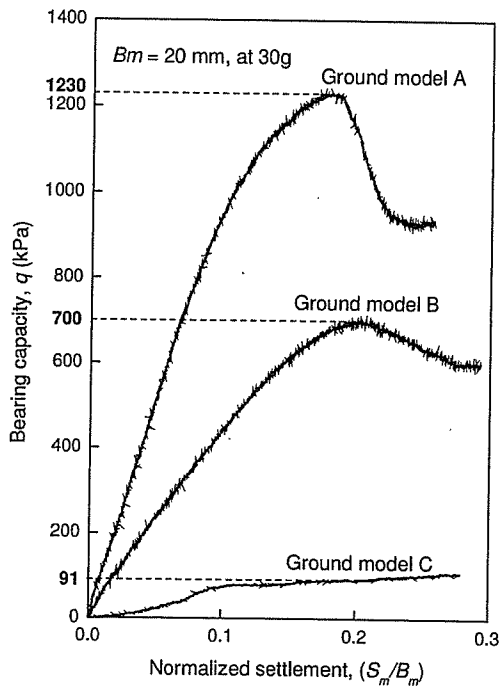
Figure 7. The bearing capacity test results

of 30g. The test results for the ground model A, B and C are presented in Figure 7, the bearing capacity, q is plotted with the normalized settlement, S_m/B_m . As can be seen in the figure, the ultimate bearing capacity of 1230 kPa and 700 kPa are observed in the ground model A and B, respectively. It is obvious that the ground model C has the lowest ultimate bearing capacity (91 kPa) when compare with the other ground models.

As can be seen in the Figure 7 and the Table 1, the bearing pressure of the machinery load (35.4 kPa) is small very about 3% and 5% of the ultimate bearing
