### 3 DETAILS OF CENTRIFUGE MODEL TESTS

#### 4 TEST RESULTS AND DISCUSSIONS

## POSSIBILITY OF MEASUREMENT OF SLOPE MOVEMENT DURING THE SANDY SOIL SLOPE FAILURE IN CENTRIFUGE

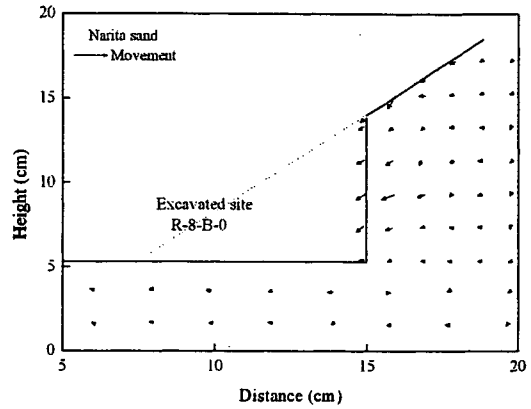
Figure 6. Movement at failure for Narita sand (R-8-B-0).

Image analysis was done from the lines drawn on the rubber membrane. Figures 6, 7 and 8 show the relative movement of slopes before the start of excavation and just before the failure. It was found that the movement behind the cut before the failure was small for Narita sand and Kanto loam in comparison to mixed soil; mixed soil showing the maximum movement while Kanto loam showing the minimum movement.

- (3) From the image analysis, failure pattern or the movement of slope behind the cut could be observed. Partial failure and smaller movement behind the cut were seen for Narita sand and Kanto loam. Whereas larger and block movement were seen for mixed soil.

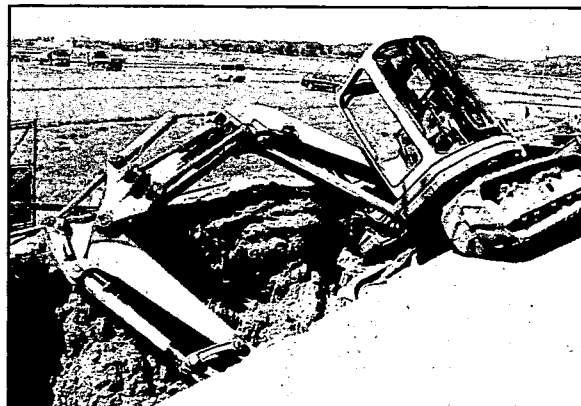
Photograph 1. Ground collapse during trench excavation

There are many labor accidents in which the workers are killed and buried under collapsed ground when the construction machinery such as a drag shovel falls or topples over the edge of the trench during excavation. Photograph 1 shows the example of the ground collapse during the trench excavation. Based on the labor accident reports, during the period of 1994 to 2002, there were approximately 30 workers killed every year in Japan due to this type of failure. To prevent the loss of life and injury caused by the ground collapse, it is necessary to gain more understanding about the effect of construction machinery load, geometry of ground excavation (e.g. slope angle and excavation depth) and characteristic of ground strength on the stability of trench excavation. Geotechnical centrifuge modelling is commonly accepted as a powerful tool for studying a wide range of geotechnical problems. The stability and failure mechanism of ground excavations have been investigated using the centrifuge modelling by many researchers (Kusakabe 1982, Taylor 1984 and Toyosawa et al. 1994). However, the stability and failure mechanism of trench excavation under the construction machinery load have not been fully investigated. Therefore, in this paper, a series of centrifuge modelling tests was conducted on various types of ground models under different magnitudes and locations of the machinery load in order to examine the stability and the failure mechanism of trench excavation under the construction machinery load.

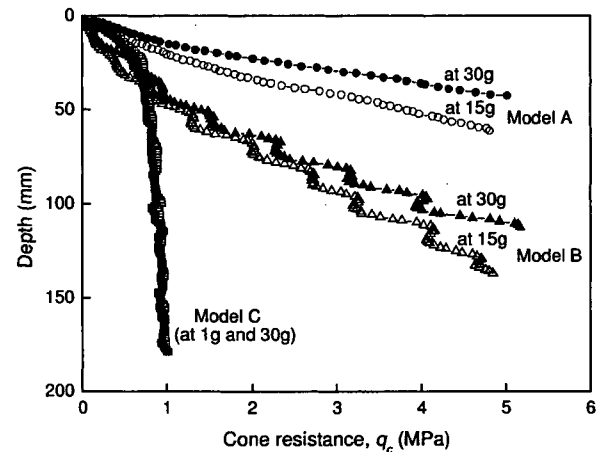
Figure 6. The cone penetration test results

in which slope of the cone resistance-depth curve drop at the depth of about 20 mm and the cone resistance remains unchanged with depth. In addition, the cone resistance of the ground model under the 1g gravity field and the centrifuge acceleration of 30g are almost identical.

This behavior may be attributed to the fact that the overburden pressure due to the self-weight of ground at the acceleration of 30g is lower than that of the preconsolidation pressure of 49 kPa, therefore, the effect of the acceleration level seems to be insignificant. The bearing capacity tests with a footing model of 20 mm in width ( $Bm$ ) were conducted at the centrifuge acceleration
