CENTRIFUGE MODEL TESTS ON INSTABILITY OF AUTOMOTIVE PILE DRIVERS

A Case Study on the Overturning of Drill Rigs on Construction Sites

実大走行実験によるくい打機の不安定化挙動の解析†

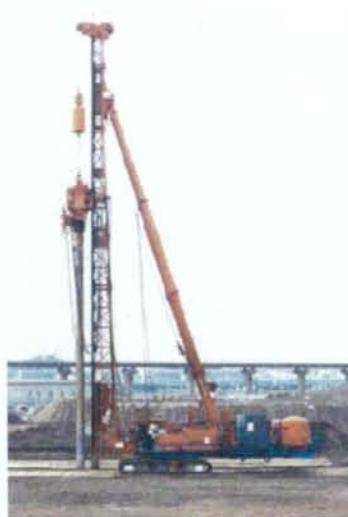
Photo 1. Automotive pile driver

The automotive pile driver (hereinafter referred to as the machinery) is mainly used for the foundation work of high-rise buildings and ground improvement. A photograph of the automotive pile driver is shown in Photo 1. This machinery is frequently used in urban areas. Recently, there have been accidents in which this machinery has overturned. In cases where the machinery topples, the risk to the lives of workers is not only a problem but this can also block trunk roads etc., having a great impact on society. Investigation revealed that overturning accidents of this machinery often occur during relocation to another pile. There are two factors in the background of the overturning of the machinery. One is structural instability stemming from a high center of gravity, and another is the ground where the machinery is set up being too soft. It is necessary to conduct a quantitative assessment of the fluctuation in the ground contact pressure while the machinery is running.

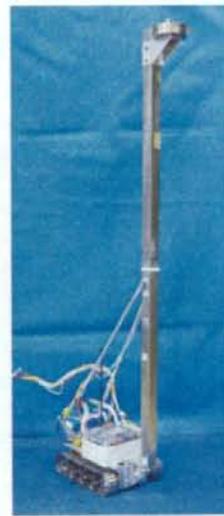
Photo 2. Automotive pile driver model

Feedback control of the rotation rate of the motor was carried out to make it possible to hold a straight line. The velocity of the model can be changed by exchanging gears. The model is operated wirelessly. The stability angle of the model can be freely changed by changing the position of the additional weight. This is because the additional weight is loaded into the construction machinery (auger, sand compaction pile, etc.). Ground contact pressure was measured on the crawler by putting the strain gauge on the arm part of each axle, which has a cantilever structure. A calibration test was carried out to investigate the relation between the load and response of strain. As a result, it was confirmed that there were linear relationships in the load and the response of strain even if 300N (30kg) was applied. In addition, the behavior of the model was measured by putting accelerometers in three places (upper part and lower part of the leader, and the body). Photo 2 shows the automotive pile driver model.

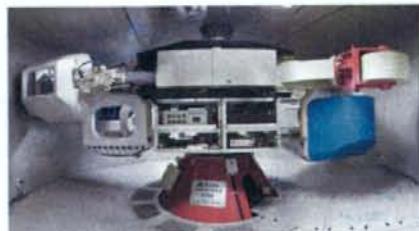
Photo 3. NIIS Mark-II centrifuge

The test of the performance (operation) of the model was carried out in a centrifuge. Centrifuge testing was performed at the National Institute of Occupational Safety and Health, Japan (NIOSH). A photograph of the NIIS Mark-II Centrifuge is shown in Photo 3. This apparatus has an effective radius of 2.3m, and the maximum acceleration of gravity is 100g. This is a medium-sized centrifuge compared to others in the world. As in other centrifuges, it has a main shaft, a drive unit, two arms, two swinging platforms, a signal and power supply interface and a control box. However, its arms are asymmetrical, which is its special feature.

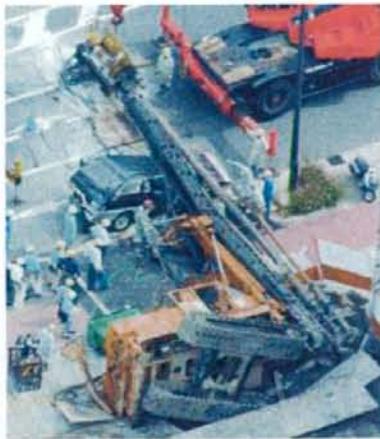
FIG.1. Overturning of a drill rig in construction site.

Some drill rigs and similar machinery for piling and ground improvements are propelled by crawlers on both sides of the lower base carrier. Such machinery must be kept near horizontal on the bearing ground when moving if the derrick is raised. Nevertheless, accidents have often occurred due to overturning of drill rigs in Japan as well as in countries throughout the world. Ground penetration by crawlers was observed in many cases where actual overturning occurred as shown in Fig 1.

The drill rig moved to the north east position to build the diaphragm walls as shown in Fig 4. However, the machinery was tilting slowly when it had reached a distance of 0.9m offset from the trench. An operator who observed the tilt quickly reversed the travel and turned the upper structure right as shown Fig 5. The increment of tilt in the machinery accelerated due to collapsed soil, and the machinery finally overturned as shown in Fig 1.
