A Case Study on the Overturning of Drill Rigs on Construction Sites

Satoshi Tamate¹ and Tomohito Hori²

実大走行実験によるくい打機の不安定化挙動の解析†

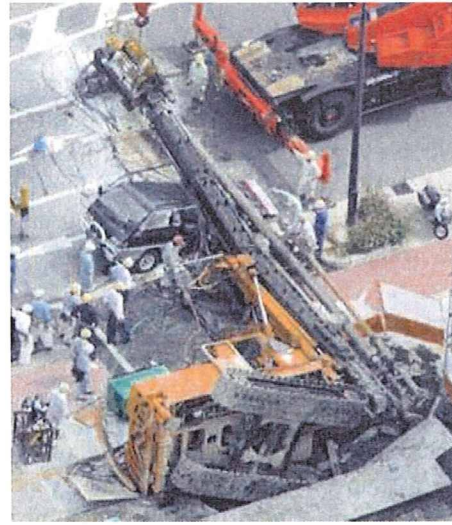
FIG.1. Overturning of a drill rig in construction site.

Some drill rigs and similar machinery for piling and ground improvements are propelled by crawlers on both sides of the lower base carrier. Such machinery must be kept near horizontal on the bearing ground when moving if the derrick is raised. Nevertheless, accidents have often occurred due to overturning of drill rigs in Japan as well as in countries throughout the world. Ground penetration by crawlers was observed in many cases where actual overturning occurred as shown in Fig 1.

The drill rig moved to the north east position to build the diaphragm walls as shown in Fig 4. However, the machinery was tilting slowly when it had reached a distance of 0.9m offset from the trench. An operator who observed the tilt quickly reversed the travel and turned the upper structure right as shown Fig 5. The increment of tilt in the machinery accelerated due to collapsed soil, and the machinery finally overturned as shown in Fig 1.

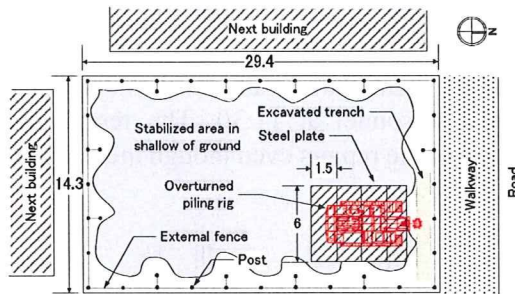
FIG. 2. Schematic view of the site.

An eight stories apartment house was being constructed at the site as shown in Fig 2. Diaphragm walls were selected as the foundation type in this construction. An external fence supported by posts was installed in the site to protect the adjacent buildings. Fig.1 shows an overturned drill rig to discuss in this paper from an incident that occurred in Japan in 2004. The drill rig comprised three augers in the leader and hit a car parked beside the site. Two workers were severely injured in this accident. Ground penetration by a crawler was clearly observed.

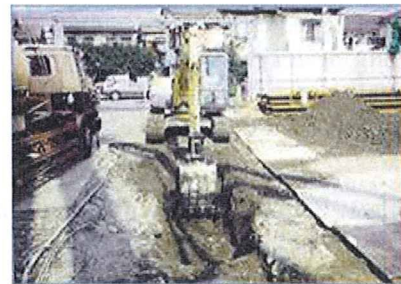
FIG.3. Preliminary trench excavation.

A small trench, 0.9m in depth and 0.8m in width, was excavated by a backhoe in the north area prior to building the diaphragm wall as shown Fig 3. This trench excavation was carried out as preliminary preparation to indicate the positions of drilling columns and to prevent the overflow of mixing mud. However, the depth of the trench was deeper than 0.7m of the designed value. The deeper trench reduced the bearing capacity near the walls, and made the drill rig unstable. This was also considered to be another cause of the accident.

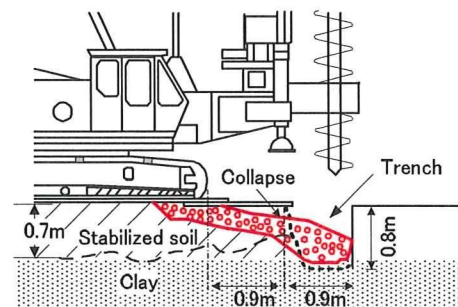
FIG.4. Soil collapse under drill rig.

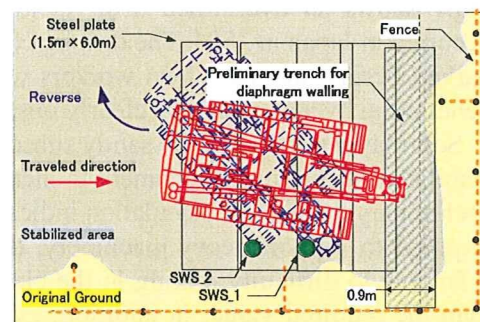
FIG.5. Location of drill rig prior to overturning.

Swedish weight sounding tests (SWS) were carried out to investigate the distribution of stiffness at the two positions of SWS_1 and SWS_2 shown in Fig.5. The N value is well known as an index to classify the ground stiffness. N-value means the number of blows in standard penetration tests that are carried out in boreholes during site investigations. The procedure is specified in BS1377. The N value is interpreted by Eq.(5) and Eq.(6) depending on soil materials.

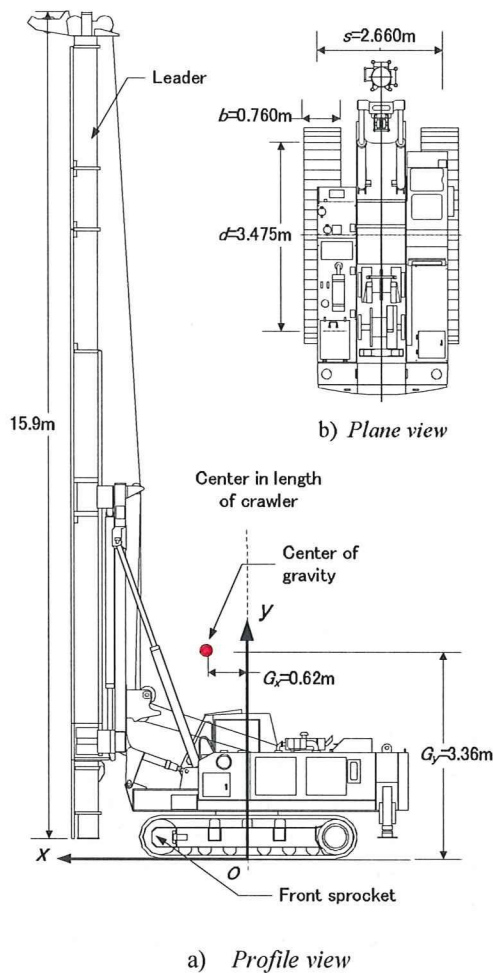
Fig 6 shows a summary of the drill rig with a leader 15.9m in length and 372.5kN in total weight (W). Since the x axis and the y axis are defined as shown Fig 6, the origin (O) is positioned at the horizontal center of the crawler on the ground surface. Coordination of the center of gravity in horizontal axis (G_x) and vertical axis (G_y) was calculated to investigate the stability of the machinery. Table 2 summarizes the specifications of the drill rig.

FIG. 6. Summary of the drill rig

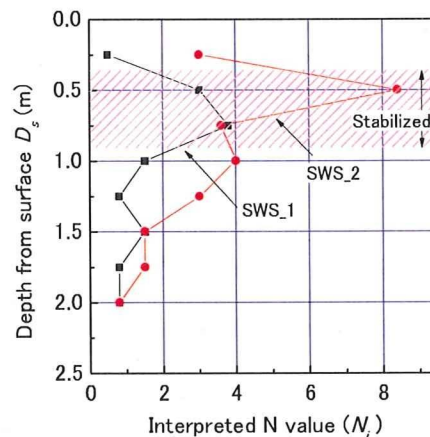
Fig 7 shows the relationship between depth (D_s) and N_i . Since SWS_2 shows higher value than SWS_1, the bearing capacity of ground is lower in the northeast corner. Both curves show the existence of a stabilized layer between 0.2m and 0.9m. Soft clay was deposited below 1m so N_i decreased rapidly. A likely difference in measured N_i was the water seepage by the broke water supply line.

FIG.7. Relationship between the interpreted N values (N_i) and depth (D_s)

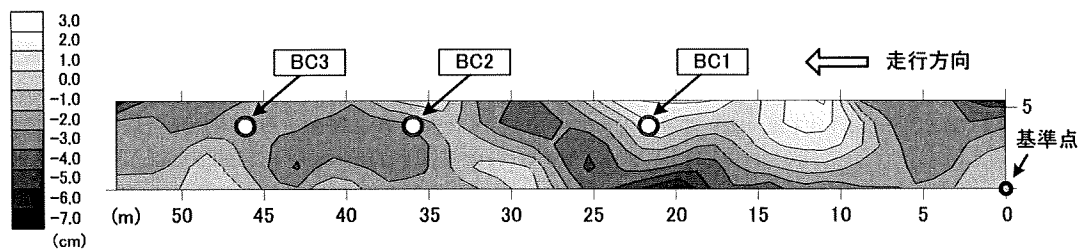
水準測量は1.8m 間隔の格子状に測点を設定し、128地点(4×32)について計測を行った。基準点の地盤高を0mとした時の高低差を図1に示す。走行路には緩やかな起伏が見られる。高低差は最大で約10cmと小さく、

図 1 水準測量の結果

ほぼ平坦な地盤である。図中のBC1~BC3は後述する平板載荷試験の実施位置である。

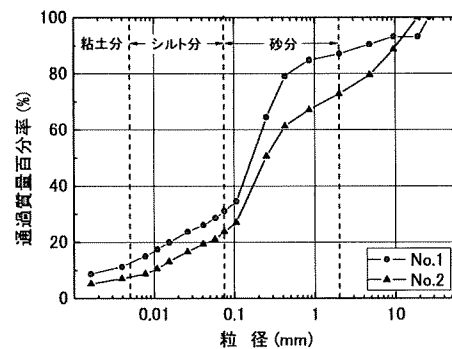
走行路地盤密度を砂置換法⁶⁾により調査した。試験に用いた砂は豊浦砂である。表5に試験結果を示す。No.1は平板載荷試験を実施したBC1の近傍における結果であり、No.2はBC2の近傍における結果である。No.1とNo.2を比較すると、乾燥密度と含水比の値に差が見られる。図2に試験孔から採取した試料の粒度分布を示す。No.1はNo.2に比べ全体的に左上に位置しており、No.2よりも粒径が小さく、粘土分やシルト分を多く含んでいる。以上の結果から、走行路の土質は箇所によってやや異なることがわかった。

図 2 採取した試料の粒度分布

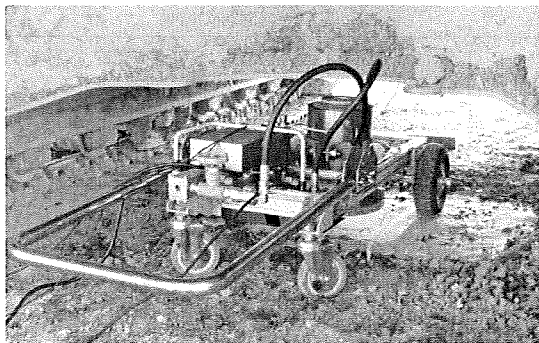
走行路の地盤支持力を調べるために平板載荷試験を行った。平板載荷試験は剛な載荷板を介して原地盤に荷重を与え、荷重の大きさと載荷板の沈下量との関係から、ある深さまでの地盤の変形や強さなどの支持力特性を調べるための試験である⁷⁾。本研究では直径 30cm の円形の載荷板を用いた。写真 1 に平板載荷試験の様子を示す。試験はひずみ制御（変位速度 5mm/min）により、図 1 に示す 3 箇所で実施した。図 3 に載荷応力 (q_n) と、沈下量 (s) を載荷板の直径 D で除した沈下比 (s/D) との関係を示す。3 つの曲線に共通して s/D が 0~0.1 の範囲では s/D 増分に対する q_n 増分が大きく、その傾き K には一致が見られる。また、曲線は $s/D=1.0$ 付近で屈曲点を示した後、ほぼ単調に増加し明確なピークを示さない。ここで屈曲点前後の 2 つの接線の交点における q_n 値を極限支持力 (q_u) と定義し、求めた値は 478~623kPa であった。BC1 地点の極限支持力が低い原因は、前述のとおり BC1 地点は BC2 地点に比べ含水比が高く、粘土分およびシルト分を多く含むためと考えられる。しかしながら、3 地点の q_u は本実験で使用したくい打機の最大接地圧 p_{max} (=196kPa) よりも 2.4~3.3 倍と高く、走行路地盤は十分な支持力を有していた。

写真 1 平板載荷試験の様子

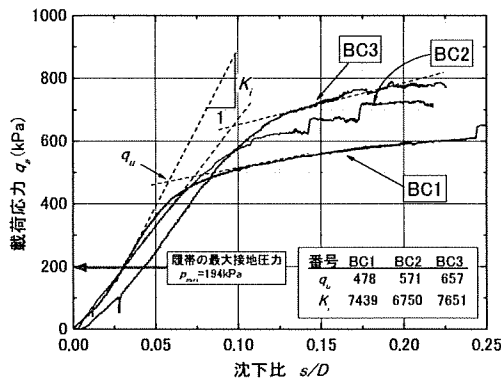
図 3 載荷応力 (q_n) - 沈下比 (s/D) 関係

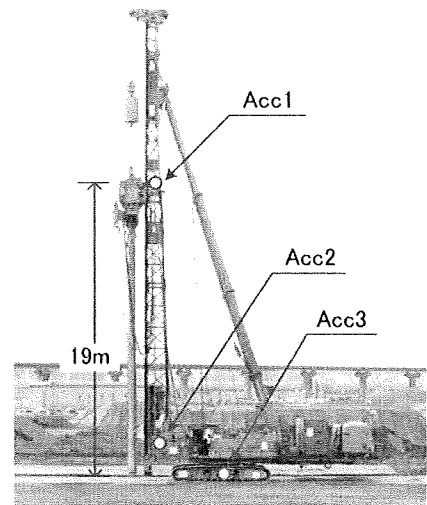
実験に使用したくい打機は写真 2 に示すサンドコンパクション用のものであり、全高 27m、総重量 980kN、

安定度 17 度、履帯の最大接地圧 194kPa である。機体の 3 箇所に加速度計を設置した。Acc1 はリーダー上部、Acc2 はリーダー下部、Acc3 は履帯支持枠の中央に設置した加速度計である。応答加速度は各箇所において進行方向成分 (A_x) と、これと直交する左右方向成分 (A_y)、上下方向成分 (A_z) をサンプリング周波数 100Hz で計測した。加速度計の極性は、 A_x は後方、 A_y は右、 A_z は上が正極となっている。

写真 2 実験に使用したくい打機

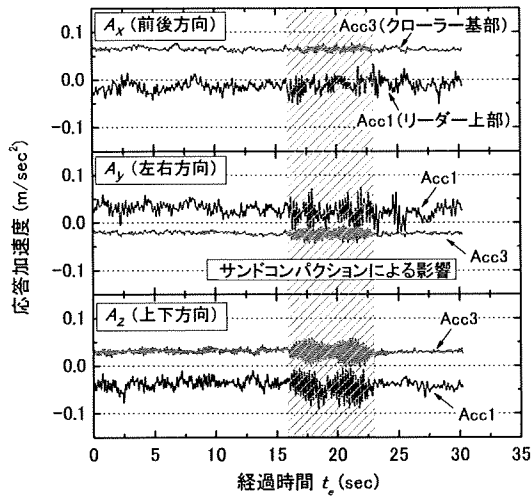
図4 応答加速度 (待機中)

実験を行った現場は 24 時間体制で施工が行われており、実験現場の近傍ではサンドコンパクションパイルの施工が行われていた。サンドコンパクションパイルは振動あるいは衝撃荷重を利用して砂杭を造成する工法である。実験現場では数十 m 離れた地点で行われている施工の振動が感じられた。そのため、計測データにはサンドコンパクションパイルの施工によるノイズの影響と、エンジンの稼働によるノイズの影響が考えられる。そこで、エンジンを稼働させた状態での待機中の応答加速度を計測した。図 4 に計測した結果を示す。図中にはリーダー上部 (Acc1) とクローラ基部 (Acc3) の応答加速度を示した。なお、電気的なノイズの影響を除去するために 5Hz のローパスフィルターを施してある。Acc1 と Acc3 の応答加速度を比較すると、上下方向 (A_z)、前後方向 (A_x) および左右方向 (A_y) 全てにおいて、Acc1 の応答が大きく、緩やかに増減する傾向が見られる。これは、計測時の風速が 11m/sec と比較的強い風が吹いていたためと考えられる。 $t=16\sim 23$ sec に大きな応答が見られる。これは、サンドコンパクションの施工による影響と考えられる。いずれにせよ、待機中の加速度応答の最大振幅は $0.03m/sec^2$ であることがわかった。

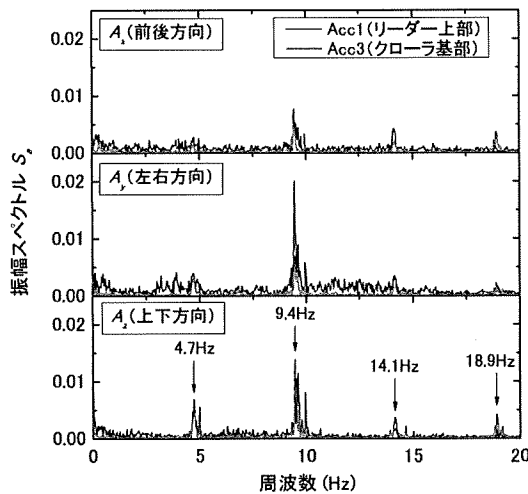
図4に示したデータの周波数解析結果を図5に示す。加速度計の設置位置、計測方向によらず、ほぼ同じ周波数成分を含んでいる。その周波数は、4.7、9.4、14.1、18.9Hzであり、4.7Hzの倍数に卓越周波数が見られることから、4.7Hzが現場周辺の振動の固有周波数であると考えられる。

図5 周波数解析結果 (待機中)

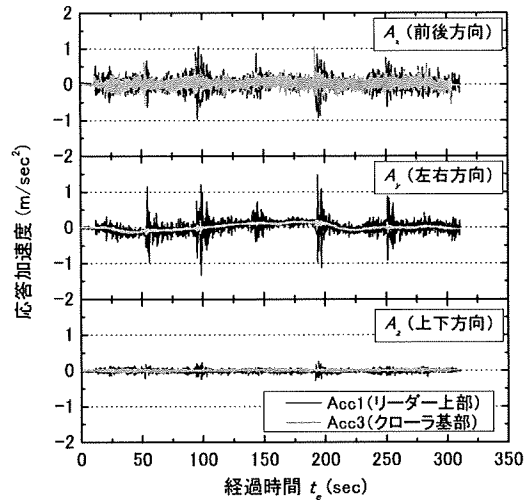
とほぼ等しいが、Ayの値が小さい。すなわち、クローラ基部の前後方向の応答加速度が卓越している。

t_e=54, 100, 147, 200, 252 (sec) 付近に見られる大きな加速度応答は、走行方向の修正動作によるものである。左右の履帯に短時間の制動を与えて進行方向を微調整している。この時、機体には大きな揺れが発生し、リーダーの上部ではつり下げられた装備が動揺した。リーダーと装備は時折衝突する様子も観察された。

図6 応答加速度 (直進走行)

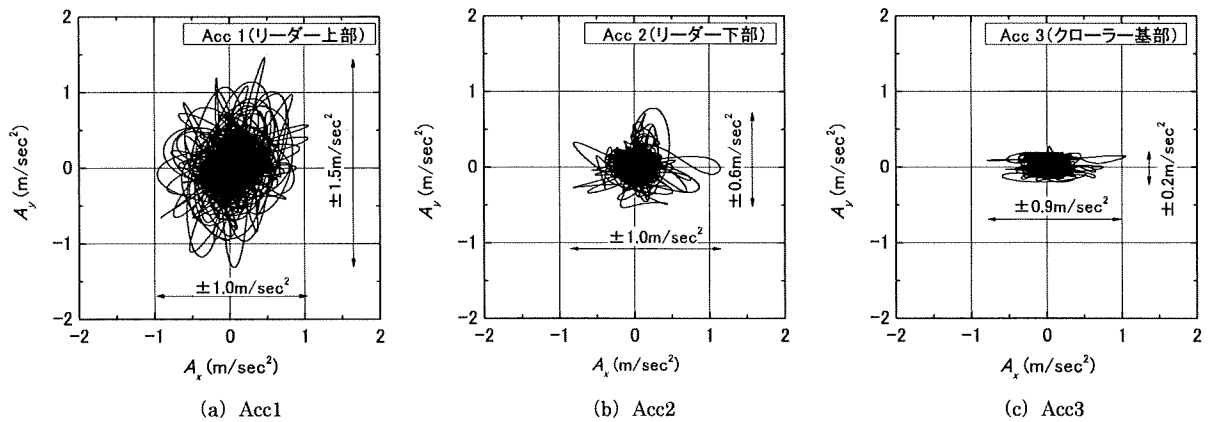
図7に応答加速度のAxとAyを平面上に表した軌跡を示す。Acc1では軌跡が縦長の楕円状に分布していることがわかる。Axの最大振幅は約1m/sec²であり、Ayでは約1.5m/sec²である。従ってAyの方がわずかに大きい。しかしながら、軌跡が集中している部分についてはほぼ円形状である。Acc2はAcc1に比べてより円形状に集中した分布が見られる。Ayの最大振幅はAcc1に比べ小さいものの、明らかに小さな範囲に集中している。Acc3では軌跡が横長の楕円状に分布している。Ayの最大振幅に比べてAxの最大振幅が大きく現れており、Acc1とは逆の分布傾向を示している。軌跡が集中する部分を比較すると、分布面積の大きさはAcc1で大きく、Acc2およびAcc3では小さい。また、Acc1ではAyの応答加速度が大きく、Acc3ではAxの応答加速度がAyに比べて相対的に大きいことが分かった。

図7 応答加速度の軌跡 (直進走行)

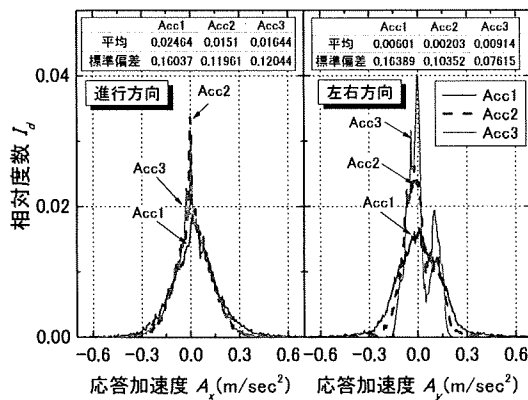
図8は応答加速度の度数分布解析の結果である。縦軸に相対度数(I_d)を示す。AxとAyについて3箇所のI_dを比較すると、応答加速度はゼロを中心にほぼ対称に分布しており、I_dのピーク値は箇所によって異なっている。Acc1の最大I_dはAcc2とAcc3のそれに比べて小さく、3箇所の中で最も変動が大きいことが分かる。この変動の大きさは図中に示した標準偏差(SD)の値の比較からも明らかである。AyについてはAcc2およびAcc3の最大I_dの値が大きく、加速度の変動が小さいことがわかる。

図8 度数分布解析 (直進走行)

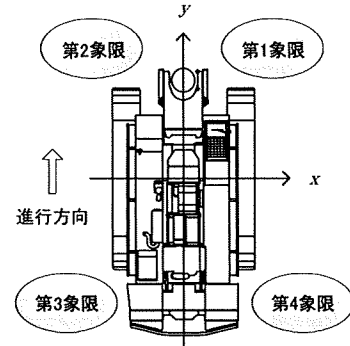
図10 象限の説明図

図7に示した応答加速度の軌跡の直交座標を極座標に変換した後、角度に関して級数間隔90度で度数分布解析を行い、各象限の分布を調べた。本研究では、図10に示すように前方右側を第1象限と定義した。図11および表6に度数分布解析の結果を示す。図中の破線は、

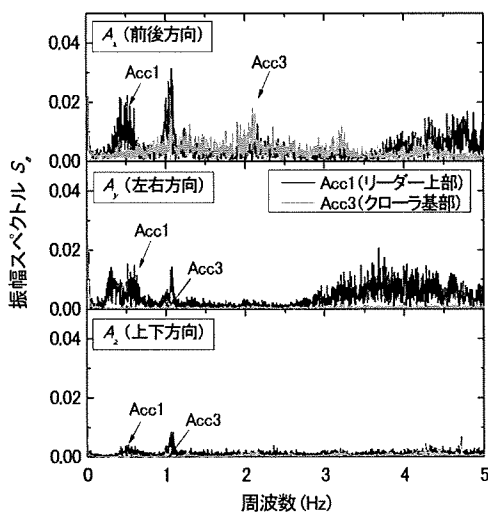
図9 周波数解析 (直進走行)

図9は周波数と振幅スペクトル(S_d)の関係を示す。Acc1では A_x と A_y の応答に増幅が見られる。 A_x については0.5Hz付近に、 A_y については0.3と0.6Hz付近に卓越周波数が見られる。これは自走時におけるくい打機の動揺特性を示すものと考えられる。なお1.1Hzに見ら

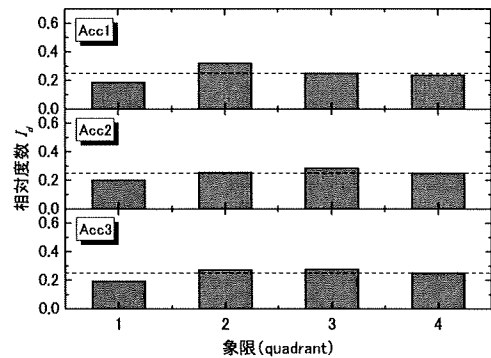
図11 度数分布解析結果 (直進走行)

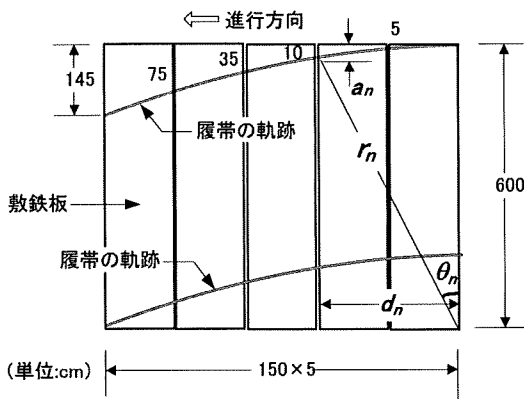
ここで、 a_n は、敷鉄板端部からの距離であり、 d_n は、走行開始地点からの距離である。曲率半径を計算した結果、平均曲率半径は 28m であった。

図 12 カーブ走行時における履帯の軌跡

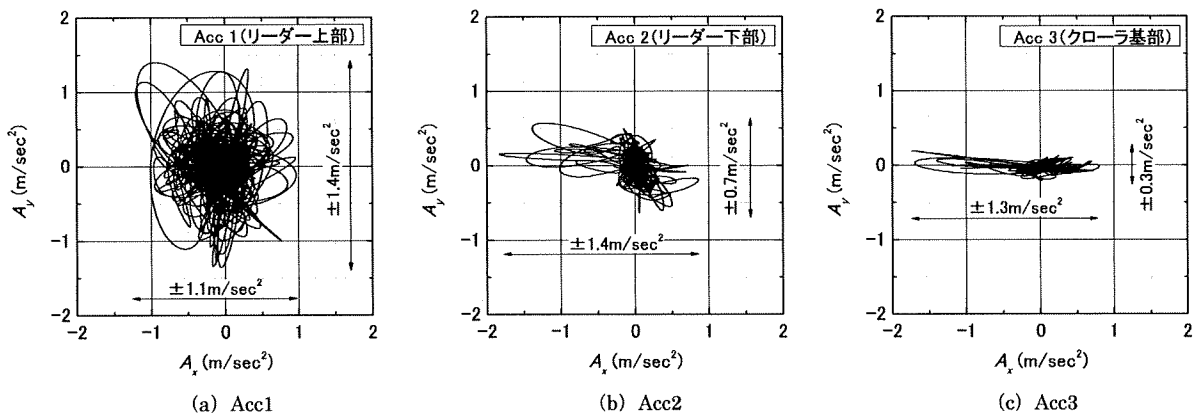
図 14 は応答加速度の A_x と A_y を平面上に表した軌跡を示す。Acc1 は直進条件と同じく楕円状に分布しているのに対して、Acc2 および Acc3 は、 A_y に比べ A_x の応答が大きく、負に大きな応答を示している。これは履帯に細かな制動を与えて進路を修正する際に生じる特徴的な応答と見られる。

図 14 応答加速度の軌跡 (カーブ走行)

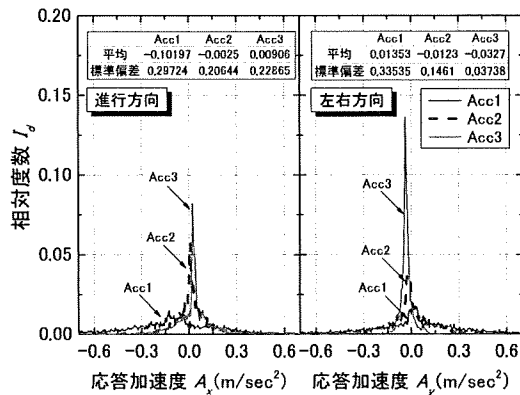
図 15 は A_x と A_y の度数分布解析の結果を示す。3 箇所における A_x の I_d 分布を見ると、Acc2 と Acc3 の平均値

図15 度数分布解析結果 (カーブ走行)

はほぼゼロである。それに対して、Acc1は -0.1m/sec^2 であり、平均値が原点から前方にシフトしており、転倒モーメントが作用している。

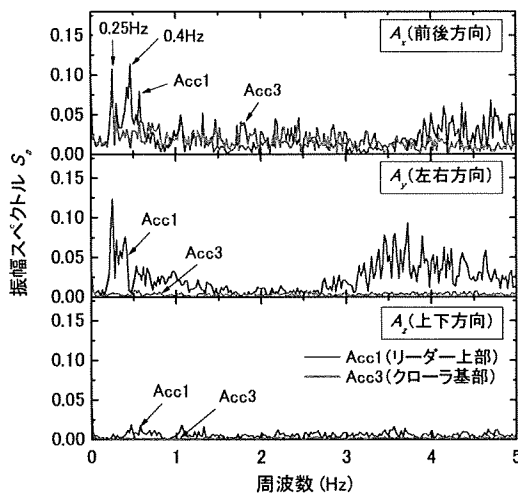
図16 周波数解析結果 (カーブ走行)

図16は振幅スペクトル S_a の周波数分布を示す。Acc1の A_x と A_y では 0.25Hz と 0.4Hz にピークが見られる。図13にも、4秒間隔で波形が大きくなっており、 0.25Hz は制動による周期であると考えられる。Acc3の A_x は 0.25Hz 付近にピークを示すものの、 A_y では加速度応答が小さく S_a に明確なピークは見られない。

カーブ走行では $0.25\sim 0.4\text{Hz}$ の長周期成分が確認され、直進走行に比べて不安定化することが明らかになった。

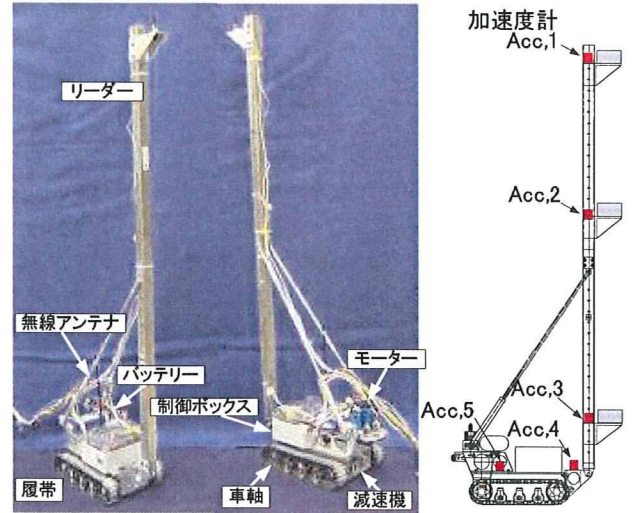
写真1 くい打機模型

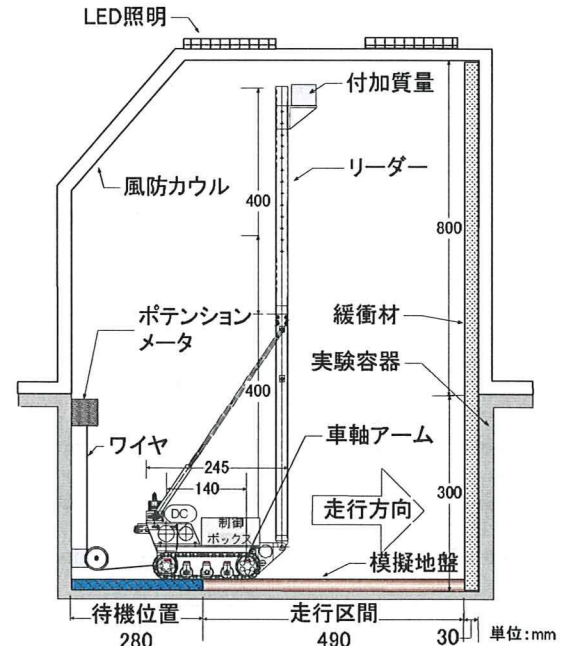
図2に実験の概要を示す。実験に用いた容器は幅250mm、長さ800mm、高さ300mmである。遠心装置の回転に伴う風の影響を排除するために風防カウルで全体が覆われている。走行時の移動距離は、ワイヤ式変位計で測定した。関東ローンを用いて作製した模型地盤を、実地盤として模擬し遠心場走行実験を行った。

図2 遠心模型実験の概要図

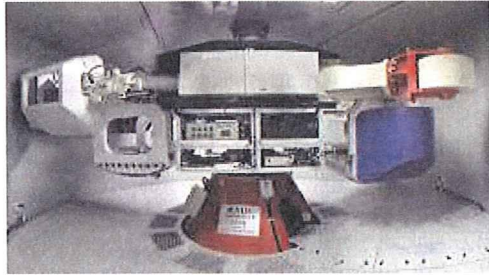
写真2は実験に使用した遠心模型実験装置（NIIS Mark-II Centrifuge）を示す。本装置の、回転半径は2.30m、最大加速度は100gである。

写真2 遠心模型実験装置 (NIIS Mark-II Centrifuge)

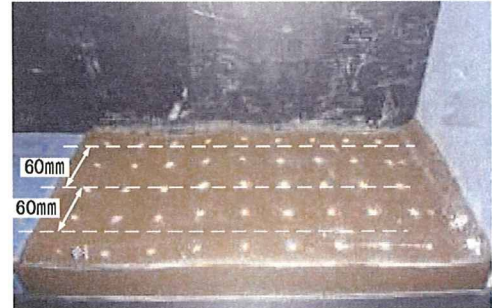
写真4は作製した模型地盤を示す。地盤に表面が形成されていることがわかる。また、白い点は、走行実験終了後にハンドベーン試験を行うポイントを示したものである。

写真4 模型地盤

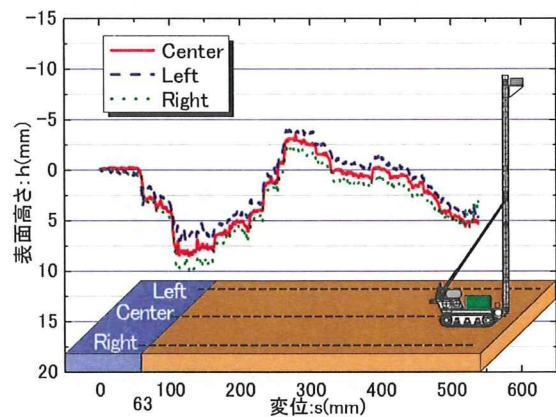
また、60mm の間隔で Center, Left, Right の 3 カ所について計測を行った。

その結果、Right の値が全体的に小さい。従って、くい打機は進行方向に対して右側が左側に比べて約 2mm 低い。しかし、その値は小さいことから、走行路はほぼ奥行き方向に対して水平とみなされる。

図3 模型地盤の表面計測

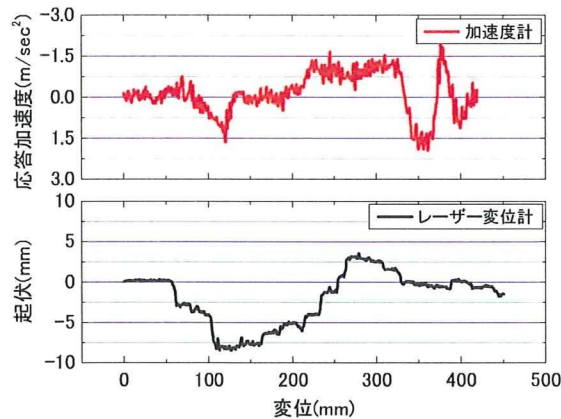
図4は模型地盤の表面形状と、小型模型のリーダー上部における応答の比較を示す。応答加速度(r_a)の値は進行方向成分を正とした。

2 つのグラフは形状が酷似していることから、応答加速度と地表形状は関係性が見られる。

図4 応答加速度と表面の関係

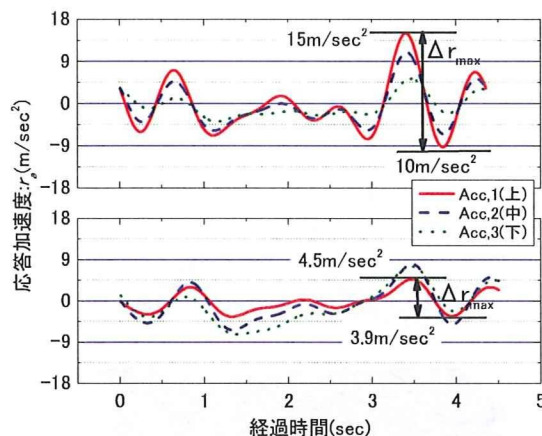
図5 応答加速度と経過時間の関係(進行方向)

図5に、リーダーの上部、中間部、下部における応答加速度(r_a)の経時変化を示す。

Acc,1における揺れの方向成分を図5と図6により比較する。 r_a の最大値と最小値の差を最大揺動と定義(Δr_{max})すると、進行方向の Δr_{max} は安定度の違いによる差が見られる。一方、左右方向の揺れはくい打機に特有の現象として現れるようであり、安定度の違いによる差が見られない。

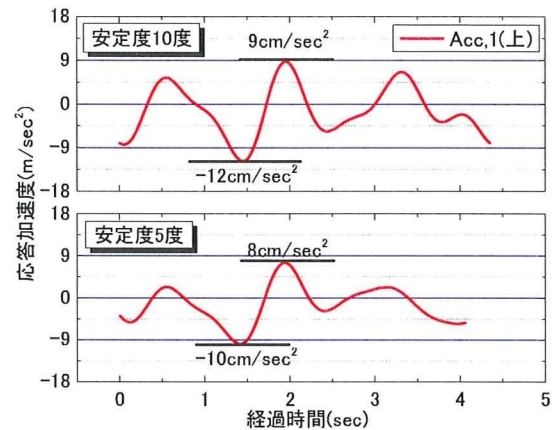
図6に、左右方向成分の r_a を示す。リーダー上部の応答加速度(Acc,1)はマイナス側が幾分、両実験結果に共通して大きく現れている。その値の偏りは、奥行き方向の傾斜に一致しており、わずかな影響が見られる。

図6 応答加速度と経過時間の関係(左右方向)

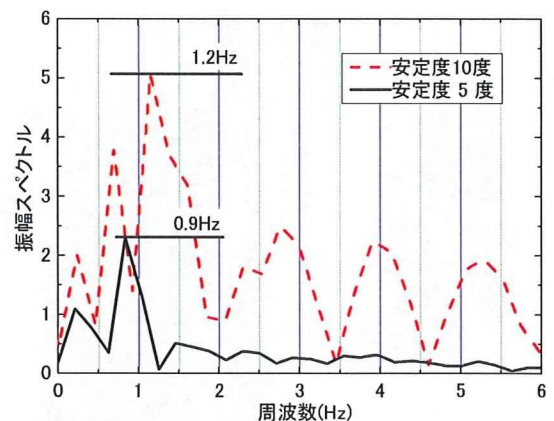
図7 周波数と振動スペクトル関係

図7に応答加速度を周波数解析して求めた振幅スペクトルの分布を示す。

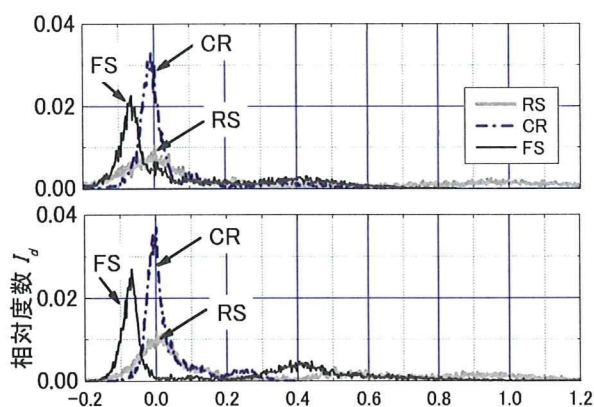
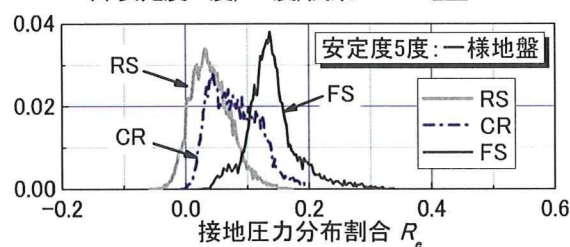
図8(a)に関東ローム地盤における安定度5度と10度の接地圧力分布割合(R_e)と相対度数(I_d)の関係を示す。ここで、接地圧力分布割合(R_e)とは、各車軸に作用する荷重から接地圧力をそれぞれ算出し、その値を全接地圧力の合計で除した値のことである。接地圧力分布割合を算出後、度数分布解析を行った。

くい打機は、前方にリーダーが搭載されていることにより進行方向にむかって転倒モーメントが働く建設機械である。そのため、履帯にかかる静的接地圧力は最前部の車軸(FS)が理論上最大となる。

図8 接地圧分布割合の度数分布解析
