斜面掘削工事中の土砂崩壊による労働災害の特徴とその対策について

Preventive Strategy for Labor Accidents Caused by Slope Failures

社会動態と地盤災害

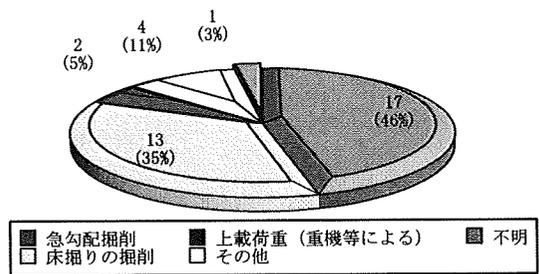
図-5 崩壊原因・施工上

施工上による崩壊原因について分類した結果を図-5に示す。急勾配掘削が17件で全体の46%、床掘り掘削が13件で35%を占めており、これらの原因により崩壊していることが分かる。

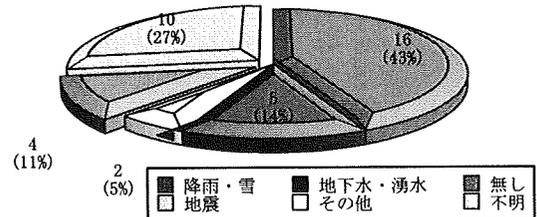
図-6 崩壊原因・自然

自然現象による崩壊原因について分類した結果を図-6に示す。降雨・雪、地下水・湧水といった水に関連する原因によって崩壊した事例が全体の約6割となっており、水が崩壊に何らかの影響を与えていることが分かる。

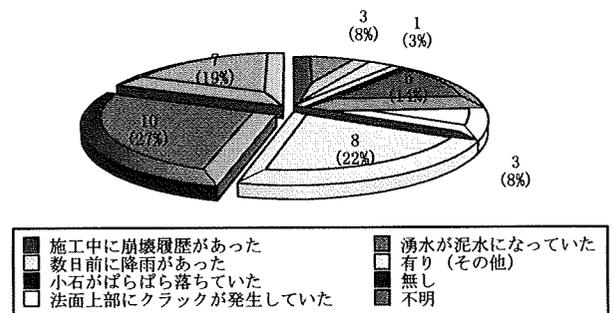
図-7 予見可能性の有無

地盤工学の専門家から見た場合の予見可能性について分類した結果を図-7に示す。不明や無しも多いが、同じ箇所を施工中に崩壊履歴があった事例や崩壊前に小石がパラパラと落ちるといった崩壊の前兆現象が報告された事例が22%存在しており、事前に何らかの処置をすれば、防げた可能性が高い。

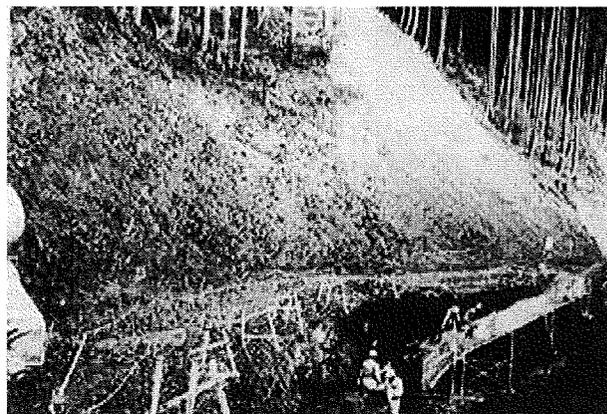
写真-1 斜面下での擁壁工の施工状況

掘削工事における土砂崩壊災害によって年間約 20-30 人前後が死亡している。このうち約半数近くが斜面関連の工事中に発生している災害である。これらの工事では、斜面は最終的には安定な構造となるものの、その施工過程において不安定な状態で作業が行われていることがある(例えば写真-1)。このような労働災害は、計画・設計・施工の各段階において適切な対策を講ずることにより解決するものと考えられる。本報では斜面掘削工事における問題を指摘するとともに対策について考察する。

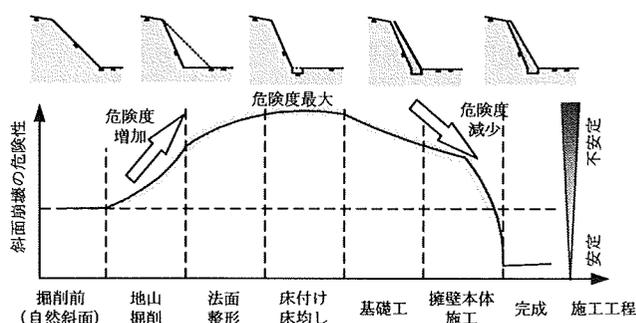
図-1 擁壁工施工途上の危険性変化の概念図

斜面を安定化する対策工としては、大別すると①擁壁工、②法面保護工がある。斜面崩壊による死亡災害の約7割は擁壁工の施工中のものが占めている現状であった。地山の掘削を始めてから切土斜面の崩壊危険性は徐々に増加していき、床付け・床均し、基礎作業時が最も危険性が高く、擁壁本体の施工まで危険性の高い状況が続くことになる(図-1参照)。

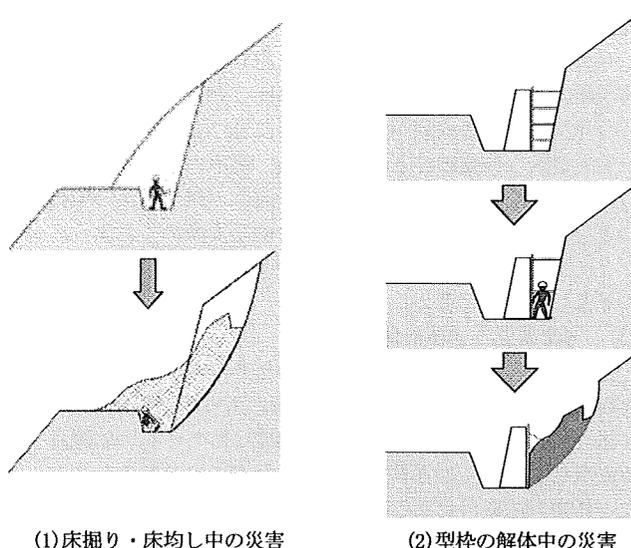
図-2 擁壁工における典型的な災害

災害発生時に被災者が行っていた作業について 121 件の死亡災害等を分析したところ、擁壁工では、擁壁築造に関連する型枠の組立・解体(20 件)や床均し(11 件)、丁張り(8 件)、ブロック積み(6 件)のように、地山・斜面掘削には直接関係しないが、切取った斜面の近くで行う作業中において被災する機会が多いことが明らかになった²⁾。擁壁工には図-2 (1) のような「床掘り・床均し中の災害」および図-2 (2) のような「型枠の組立・解体作業中の災害」が典型的な災害である。

(1) 床掘り・床均し中の災害

(2) 型枠の解体中の災害

図-2 (1) に示すような床掘り・床均し作業に関しても人が斜面下に入って寸分たがわず仕上げる必要性があるのか疑問のあるところである。①床掘りの必要がない擁壁の形式・構造とする、②バック・ホウなどで構造上必要な精度で仕上げてもいいとする、などの対策を考える必要があると思われる。

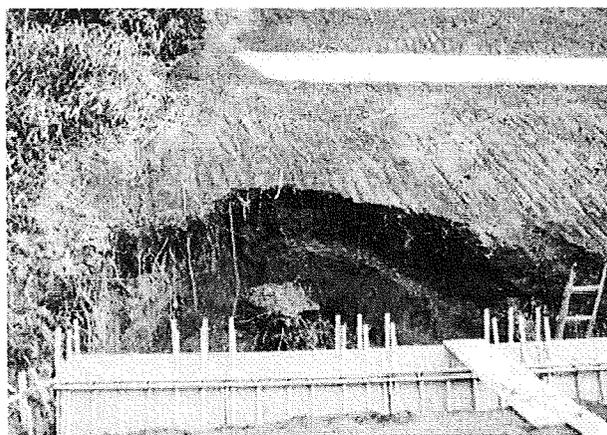
写真2 型枠解体中の災害事例

写真-2 および 3 は型枠の解体・組立て中に発生した災害現場の写真である。切り取った斜面と型枠の間に行う作業は、斜面崩壊が発生した際に逃げるできない最も危険な作業のひとつといえる。排水の確保など解決しなければならない問題もあるが、裏側(斜面側)の型枠などを埋め殺す(取り外さないでそのまま埋めてしまう)ことにより、人が入らなくてもいいようにするなど、工法の見直しが必要と考える。

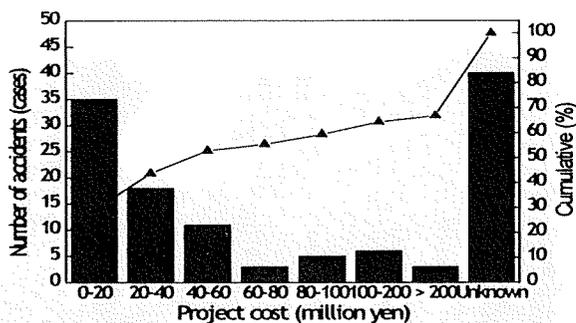
Fig. 2 Project cost

Figure 2 shows the number of labour accidents classified by the project cost. The possibility of accident is lower in the construction work with a higher amount of project cost. It was found that about 30% of accidents involving the construction work with the project cost less than 20 million yen. By considering the number of accidents related to the construction period, about 60% of the accidents occurred in the construction project with construction periods of less than 6 months. Figure 3 shows the number of workers present at the time of accident; 84% of the accidents occurred in construction project with less than 8 workers on the construction site. Because the number of workers can be related to the size of the contractor, therefore, the possibility of accident is higher with the small contractor. This is probably due to the fact that the small contractors may not have operation chief and/or worker with appropriate knowledge concerning safety and health management and they may not have sufficient budgets to provide adequate safety equipment. Based on these findings, it can be concluded that the labour accidents are likely to occur in the small construction project with small project cost and relatively short construction period conducted by the small contractor.

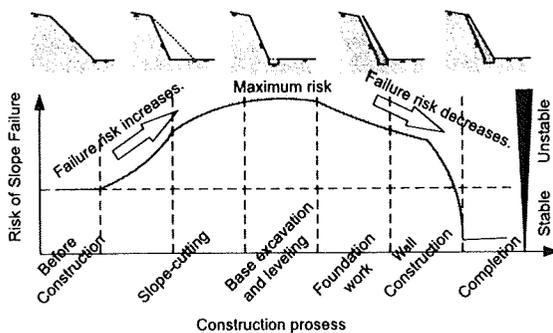
Fig. 7 Time history of slope failure risk due to retaining wall construction works

There are two general construction methods for stabilizing slope: retaining wall and slope protection methods. Based on the investigation conducted in this paper, it was found that about 73% of the labour accidents occurred during works involving slope stabilization by the retaining wall method. In contrast, the number of accidents that occurred during works using the slope protection method was smaller (about 12%). This is probably due to the fact that the retaining wall construction generally includes the excavation of steep and unstable slope (Figure 4 (a) and Figure 5 show), and it also requires construction works to be done in a narrow space between the retaining wall and the excavated ground such as assembling/dismantling of formworks (Figure 4 (b) and Figure 6 show), smoothing of base and etc. Therefore, workers do not have sufficient time to escape from such narrow space when slope failure occurred. The accident often occurred during the assembling/dismantling of formworks, ground/slope excavation, smoothing of base, excavation of the base and during erection of concrete block masonry. Figure 7 shows the relationship between slope failure risk and construction process of retaining wall construction works.
