Rainfall-induced slope failure in Northland Allochthon formation

ABSTRACT: During the winter season of 2008, a section of the roadway embankment adjacent to State Highway 1 in Silverdale, New Zealand, collapsed as a result of heavy rainfall. The failure occurred in a cut slope through the landslide-prone Northland Allochthon formation. To investigate the response of this formation to rainwater infiltration, volumetric water content transducers and a rainfall gauge were installed through a cross section 45 meters away from and parallel to the failed slope and during the winter period of 2010, monitoring was performed. Saturated/unsaturated seepage analyses were then conducted to simulate the variation in the monitored volumetric water contents. After modeling the hydraulic properties, slope stability analysis was conducted to investigate the failed slope. This paper presents the partial results of the ongoing monitoring of the slope and the attempt to simulate the failure through seepage analysis and slope stability analysis.

明かり掘削における掘削面の勾配と高さの基準制定に至る歴史的背景

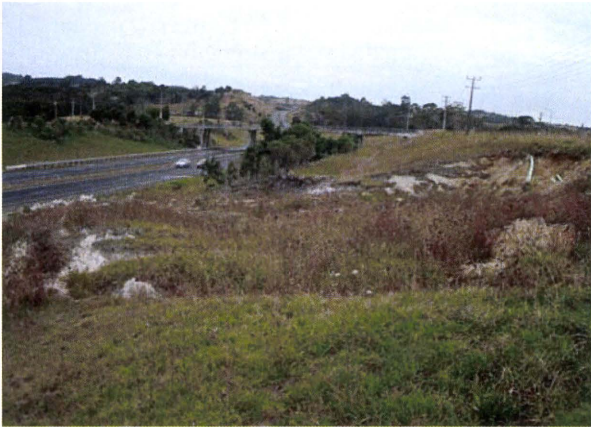
Figure 1. The monitored site. The landslide occurred in the winter of 2008. State Highway 1 can be seen at the toe of the slope.

The site, shown in Figure 1, is located in Silverdale, approximately 30 kilometres north of New Zealand’s largest city, Auckland. It was formed from an 11m cut operation during the construction of State Highway One, which lies at the toe of the slope. This site was selected because of the effect a future landslide occurring at this site would have on the

roading network. Because the site is man-made, it is also linear along its length, making the 2D numerical modelling viable. The slope angle is approximately 15° , which is similar to many natural slopes in the region (O'Sullivan, 2009). A bench was formed at mid-height of the slope, with counterfort trench drains discharging onto a dish drain placed on this bench. A subsoil drain is located at the toe of the slope. The site is grassed, with a row of low height trees and shrubs present at mid-height of the slope. The soil at the site largely consists of Northland Allochthon residual soil.

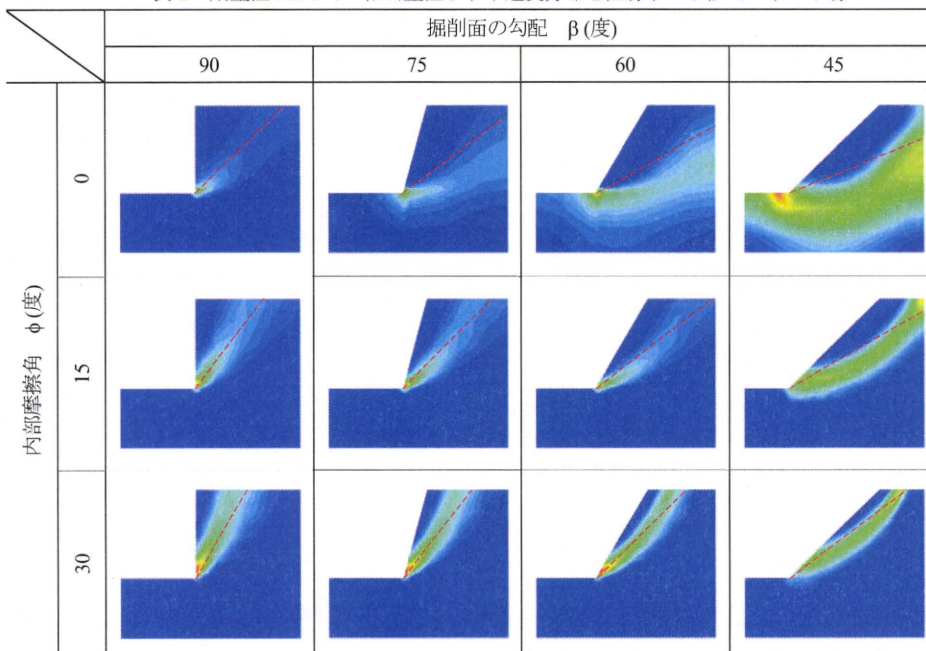
表-2 剛塑性 FEM での相当塑性ひずみ速度分布と直線すべり法でのすべり線

剛塑性有限要素法より得られた相当塑性ひずみ速度分布の一覧を表-2に示す。この表には、直線すべり法にて得られるすべり線勾配も赤色点線で一緒に図示した。内部摩擦角が小さい、すなわち粘性土地盤のケースでは、崩壊形状が円弧状となっており、直線すべり法によるすべり線勾配とは全く異なる。しかし、内部摩擦角が大きい、すなわち砂質土地盤では、崩壊形状が表層部分に集中し、直線すべり法によるすべり線と合致する。また、勾配の違いで見ると、急勾配ほどすべり線形状は内部摩擦角が小さい場合でも直線となる傾向が見られた。直線すべり法では、このようなすべり線の違いが安定係数にも大きな影響を与えたものと想像される。しかし、急勾配掘削において簡易的に安定係数を求める場合には、直線すべり法でも大きな差とはならないと言える。
