STUDY ON FALL PROTECTION FROM SCAFFOLDS BY SCAFFOLD SHEETING DURING CONSTRUCTION

K. OHDO^{1*}, Y. HINO¹, S. TAKANASHI¹, H. TAKAHASHI¹, and Y. TOYOSAWA²

¹ *Construction Safety Research Group, National Institute of Occupational Safety and Health, Japan*

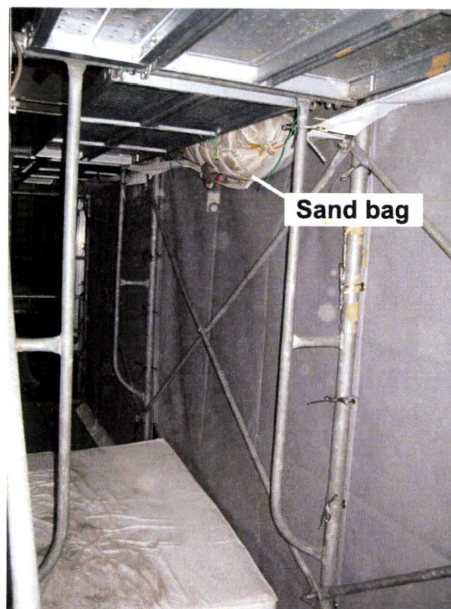
Photo 6: Result of case 3.

Table 2 shows the results of the experiment. For cases 1-2, the sand bag fell below the work platform. Therefore, the fiber ropes and the steel wire with 1.0 mm diameter were severed by the mass of the sand bag. However, the sand bag did not fall below the work platform for case 3, as shown in Photo 6.

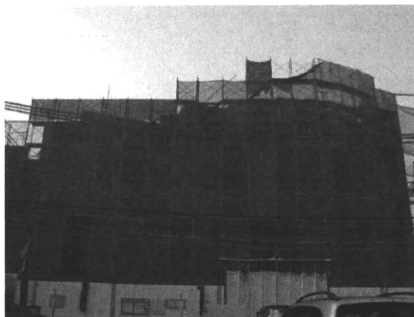
Photo 1. Scaffolds covered with sheeting

From the results and the discussion, it was found that the workers sometimes fell from the space between the hand rail and the work platform. To prevent the fall of the workers from the space, the space have to be made narrow. The scaffold sheeting, which covered around the scaffolds and widely used in Japan, as shown in Photo 1, had a few effects for this purpose according to the experiment by the committee. However, the workers still occasionally fell from the space between the work platform and the scaffold sheeting. One reason is because the space was spread by the workers weight, and the workers fell from the spread space. Therefore, in this study, the scaffold sheeting, of which material was plastic, was improved for fall protection from the spread space, and the effect of the improved plastic sheeting was examined experimentally.

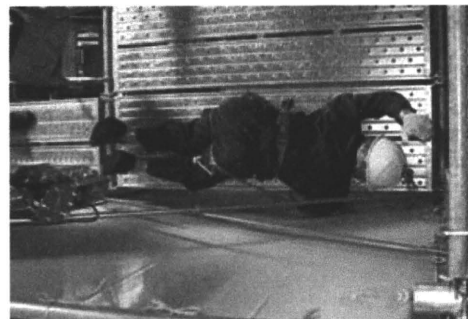
Photo 2. Typical prefabricated scaffolds

Photo 2 shows the typical prefabricated scaffolds used in Japan. It was considered that the plastic sheeting, which envelop the scaffolds, are able to protect the workers from falling, but their effectiveness was not clear. Therefore, their effectiveness was examined experimentally using a human dummy. The human dummy weighed 700 N, the average body size of Japanese males. Table 1 shows the experimental cases.

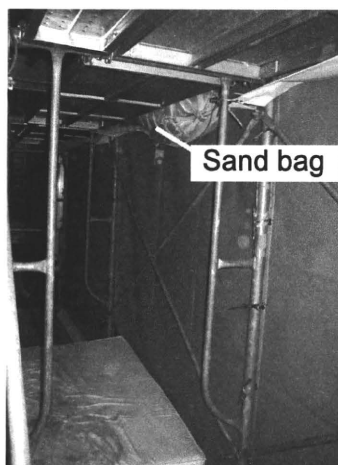
Photo 5. Result of case 3

Table 3 shows the results of experiment. For cases 1-2, the sand bag fell below the work platform. Therefore, the fiber ropes and the steel wire with 1.0 mm diameter were cut by mass of the sand bag. However, the sand bag did not fall below the work platform for case 3, as shown in Photo 5.

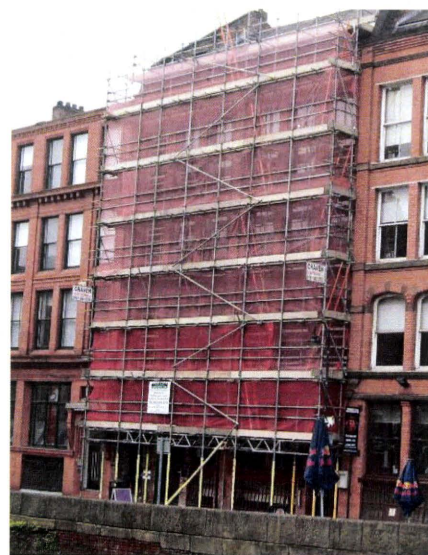
写真1 英国における足場の状況

これを海外にも目を向け、欧州三カ国(英国、ドイツ、フランス)および北米二カ国(米国、カナダ)の状況について調査すると、各国とも二段手すり(国によっては幅木)の設置が義務付けられており、ほぼすべての現場で実施されていた^{1,2)}(写真1参照)。また、米国ではわく組足場が主流であり、交さ筋かいの下に下さん(交さ筋かいの交点の位置によっては上さん)の設置が義務付けられており、ほぼすべての現場で実施されていた(写真2参照)。以上より、今回の改正規則により欧米と同等の墜落防止措置が義務付けられたことになるが、それまでわが国ではメッシュシートが墜落防止に何らかの役割を果たしてきたと考えられる。

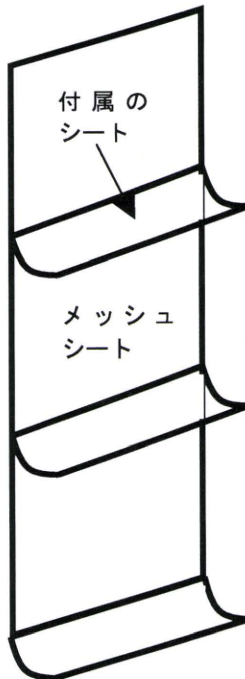
図1 改良したメッシュシート

これまでの研究⁴⁾では、図1に示すようにメッシュシートを改良したものを製作し、作業者の落下空間を完全に塞ぐ方法について検討を行った。その際の実験条件と結果を表1に示すが、鉄筋等を結束する番線により図1に示す付属のシート(メッシュシートと同じ材質のもの)と作業床を結束すれば、落体として使用した質量75kgの人体ダミーの落下を防止することが可能と

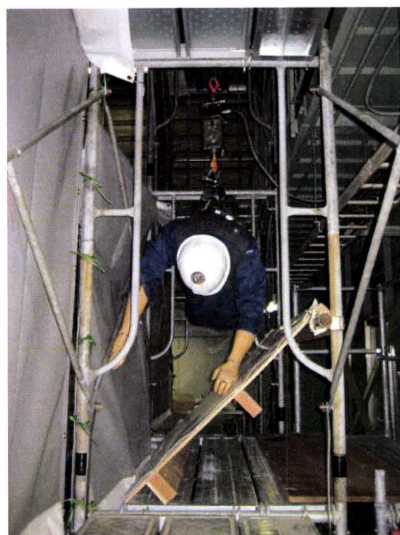
写真3 実験前の状況

なることがわかった。しかし、1回実験が終了するたびにメッシュシートを張り替えたため、付属のシートの耐久性が確認できなかったこと、番線での結束では作業性が劣ること等の問題が残されていた。そこで、本研究では、付属のシートの耐久性を確認するため、作業床に取り付けた付属のシートを交換せずに複数回の落下実験を行った。実験の状況を、写真3に示す。その際、人体ダミーの質量を75kgから85kgに増加させ、さらに人体ダミーの落下高さを1000mmに固定して、耐久性に加えさらなる安全性についても検討することとした。また、写真4に示すように付属のシートと作業床の結束を、通常のメッシュシートの結束に使用す

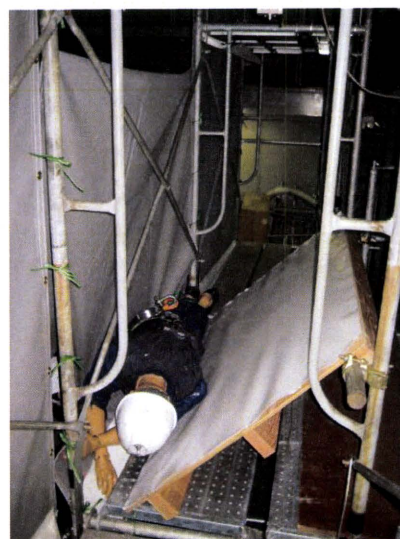
表2に、本研究における実験条件と結果を示す。その結果、同一の付属のシートに対する実験により、6回目までは写真5に示すように人体ダミーの落下を防止することができた。また、2本に撚った繊維ロープについては、目立った損傷は見られなかった。これより、本研究の方法により高い墜落防止性能とある程度の耐久性があることが確認できた。しかし、7回目の実験では写真6に示すように、メッシュシートと付属のシートの接続部が破損して人体ダミーが落下した。今後は、この接続部の補強について検討し、安定した墜落防止性能を発揮できるように改良していく予定である。

写真5 実験後の状況(落下せず)

写真6 実験後の状況(落下)

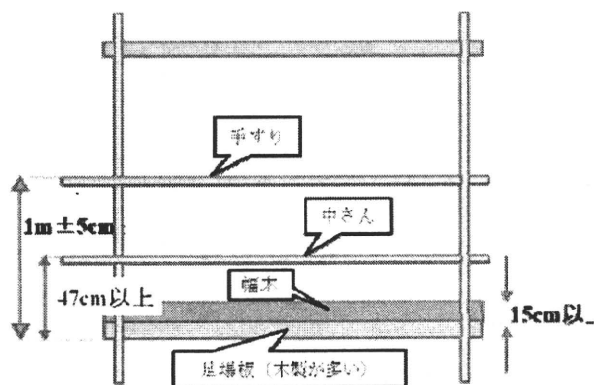
図1 ドイツにおける足場の設置規定

ドイツの足場規格は、欧州における共通規格となりつつあるEN規格²⁾がベースとなり、国内規定³⁾として作成されたものになっている。建設労働者の墜落防止対策としては、“2段手すり”を基本とし、上さんについては高さ1m±0.05m、“中さん”については床上0.47m以上とするものであった。また“幅木”については、高さ0.15m以上に設置し、労働者の墜落防止用ではなく、物体の落下防止用として用いられる、というものであった（図1参照）。なお、枠組み足場で用いられる“交差筋かい”は、日本においては手すりとみなされているが、同規定では、このような規定は存在していないようであった。

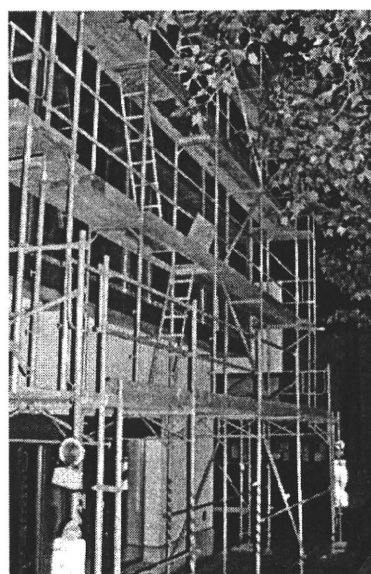
写真1. ドイツにおける足場の設置状況

フランクフルトならびにベルリンの市街地における足場の基本構造は、ほぼすべてにおいて2段手すりに幅木を設けた構造となっていた（写真1参照）。このほか日本との比較で特徴的な事は、①交差筋かいを用いた足場が見られなかった事、②足場用階段が足場板に組み込まれている事、③足場材料として用いられる単管式足場の単管直径が大きい事、④足場板には木製のものが多く用いられていたこと（写真2）が挙げられる。また足場用シートは、景観に適合するようペイントされていたのが印象的であった。
