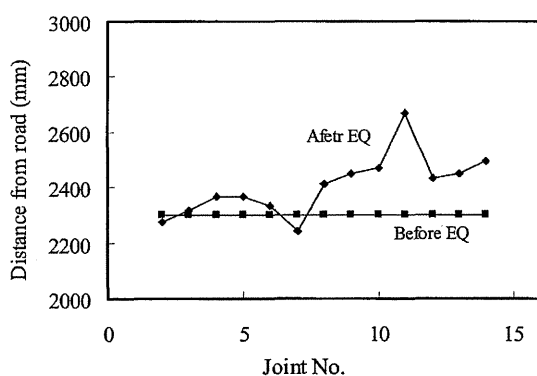
Figure 2 illustrates a horizontal distance to a pipeline from the edge of a road before and after the earthquake. Because the road was not dislocated horizontally or deformed by the earthquake and tsunami, this figure indicates that the pipeline moved about 40 cm. Figure 3 shows the bending angles at joints measured at the field. The maximum bending angle is 7.5 degrees at the joint No. 11. It seems that the pipeline was exposed above ground by the scouring, hit by a steel container and debris in undertow of the tsunami, and moved to the coastline. There was, however, no damage to ERDIP and water suspension did not occur.

Figure 2 | Distance to the pipeline from a road edge before and after the earthquake.

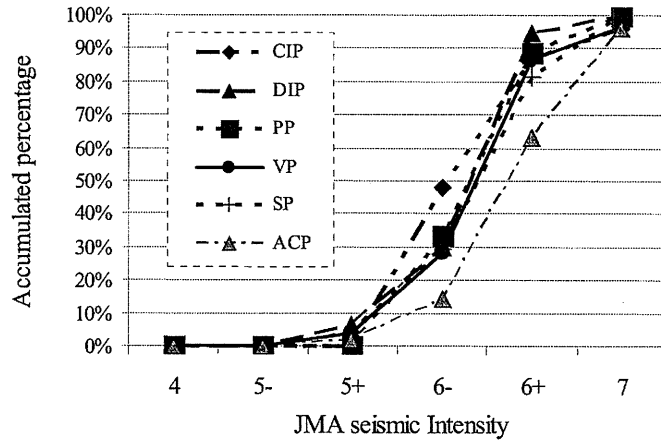
Figure 5 | Accumulated damage rate of each pipe type.

The main types of buried water pipes in Japan are ductile cast iron pipes (DIP), grey cast iron pipes (CIP), steel pipes (SP), polyethylene pipes (PE), polyvinyl chloride pipes (PVC), and asbestos cement pipes (ACP). Figure 5 illustrates an accumulated damage rate of each pipe type. This figure indicates that the damage to pipeline starts to occur at 5+ of JMA seismic intensity and the damage rapidly increases at 6+.
