Verification of a Prediction Method of Earthquake Damage to Water Supply Pipeline by Using Damage Data of the 2011 Great East Japan Earthquake

Application of Two-stage Coagulation for High Turbidity Raw water

Simplified Evaluation Method of Seismic Resistance for Water Treatment Facilities

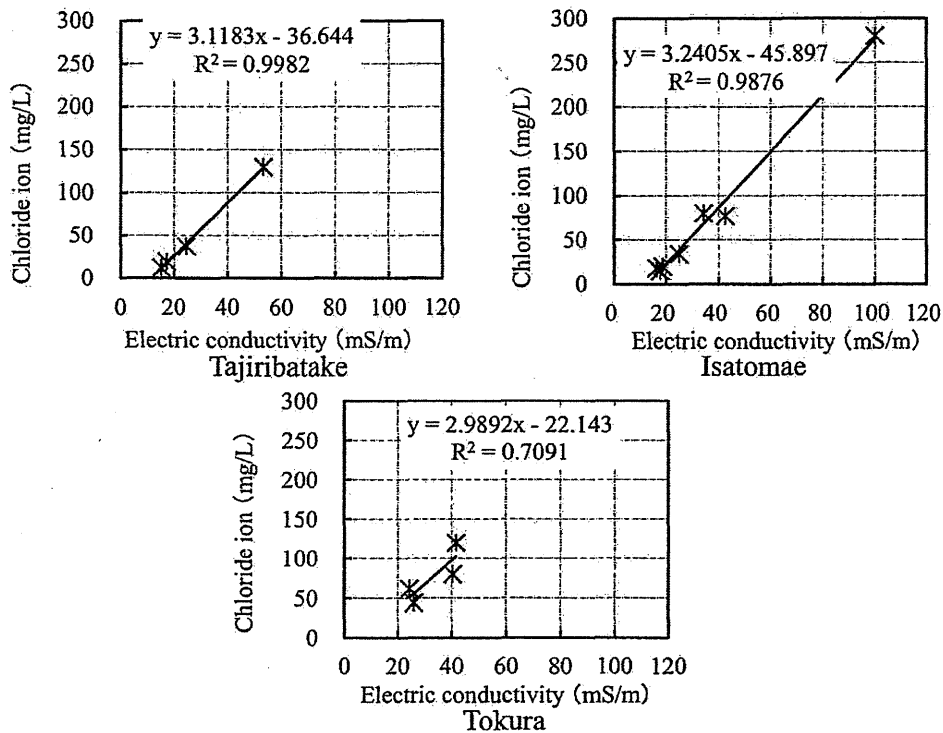
Figure 5. Correlation between chloride ion concentration and electric conductivity

Figure 5 shows the correlation between the chloride ion concentration and electric conductivity. As the figure reveals there is a high correlation between the chloride ion concentration and electric conductivity, with the slope being about 3. This confirms that electric conductivity can be used as an indicator of the chloride ion concentration. The decision was therefore made to install compact electric conductivity meters at the water sources in thereby enabling constant measurement of the transition in the chloride ion concentration, being in addition to periodic manual analysis.

To measure the long term change in chloride ion concentration we installed an electric conductivity meter at the water source as an alternative indicator, and which enabled constant measurement of the concentration. Figure 8 shows the monthly fluctuations in the electric conductivity at the Sukezukuri water source and tide level, rainfall, and electric conductivity before the disaster (calculated from the chloride ion concentration before the disaster and based on the correlation equation provided in Figure 5).

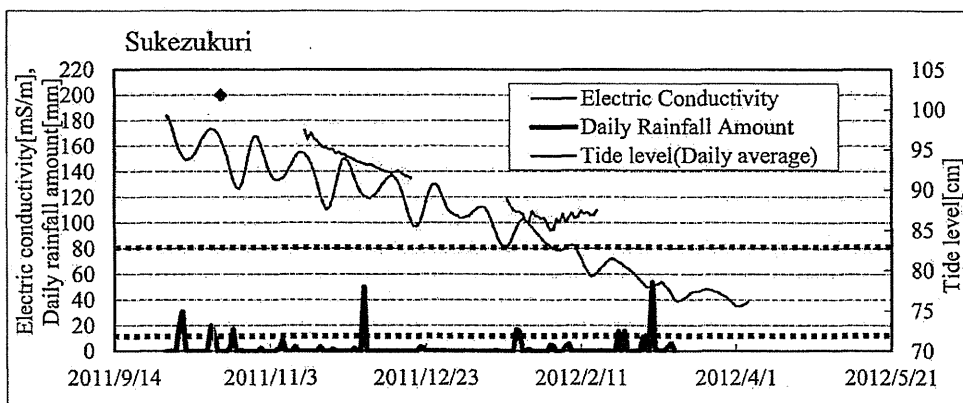
Figure 8 reveals there to be no correlation between the electric conductivity and monthly tidal change, with the electric conductivity decreasing in a uniform manner. In addition, about 50 mm/day of rain fell on 3 December, 2011, but no change was observed in the electric conductivity, which then revealed that rainfall of about 50 mm/day had no effect on the electrical conductivity.

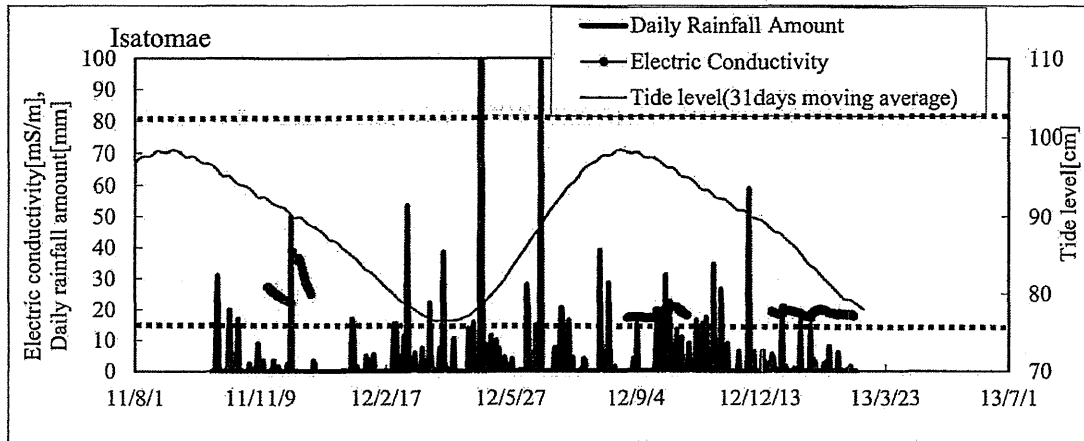
The results of a survey on the correlation between the annual fluctuations in electric conductivity and tide level and rainfall are shown in figure 11. The results reveal that even in August, when the tide was its highest level of the year, the electric conductivity didn't significantly increase and basically remained at the same value as in winter or even lower, thus indicating that the tidal change has no major effect on the quality of the water sources. As with the Sukezukuri water source we were unable to collect any data during the heavy rain that fell in May and December 2012, and hence the effect of heavy rain has not been completely identified.

As revealed above no significant change was observed to have resulted from the tide level at the Isatomae water source, and the chloride ion concentration has decreased to near the level it was before the disaster. The concentration is unlikely to be affected by small amounts of rainfall (50 mm/day), but the fluctuation in chloride ion concentration does need to be constantly monitored after heavy rainfall as it is easily affected by rainfall.

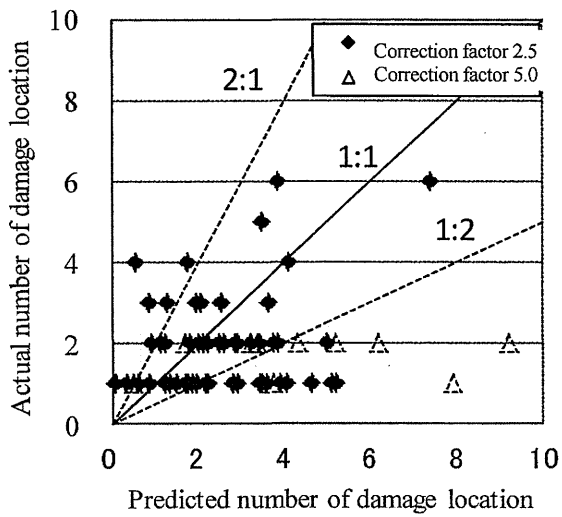
2.0 of the ration. Since the correction factor is different in microtopography type in the prediction method, the relation between the actual number of damage and predicted one in each microtopography type is drawn in Figures 2 and 3. The actual number of damage is relatively larger than the predict one in case of law correction factors for microtopography type according to Figure 2. This discrepancy is probably due to land use change for housing development. Thus, the microtopography map of 250m x 250m cell is not sufficient for locally change of landform.

Figure 2 Comparison of actual number of damage with predicted one of correction factors 0.4 and 1.0.

Figure 3 Comparison of actual number of damage with predicted one of correction factors 2.5 and 5.0.

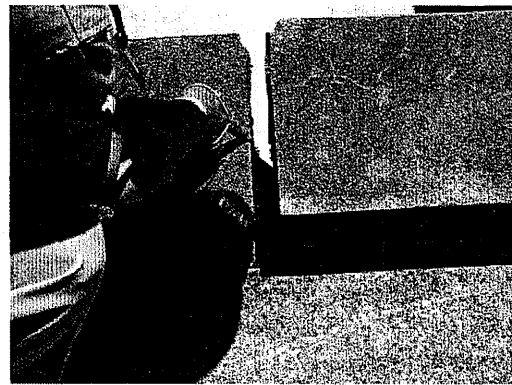
Photo 2. Concrete expansion joint forced widened due to ground deformation (Hebita WTP)

Damage by the Great East Japan Earthquake. Of the five government agencies, four responded to the questionnaire. The result showed there were breakage or fall of plate settlers at some WTPs but there were none but three plants that were forced to suspend water supply for extended periods due to critical damage. Subsequently we made on-site investigations of the three plants (Hebita in Miyagi, Wanigawa in Ibaraki, and Shinjuku in Chiba). The follow-up investigations revealed that the primary cause of the damage was not the ground shaking itself but the ground failure due to liquefaction. Afterwards we examined and found this was also the case in the 1995 Kobe Earthquake as well as subsequent earthquakes: the critical impact on the WTPs was brought about largely by the liquefaction effect, and the other effects played a minor role.
