地震被害実態に基づく浄水施設簡易耐震診断手法の検討

DAMAGE TO WATER SUPPLY SYSTEM INDUCED BY THE 2011 GREAT EAST JAPAN EARTHQUAKE

Masakatsu MIYAJIMA

Damage Analysis of Water Supply Facilities in the 2011 Great East Japan Earthquake and Tsunami

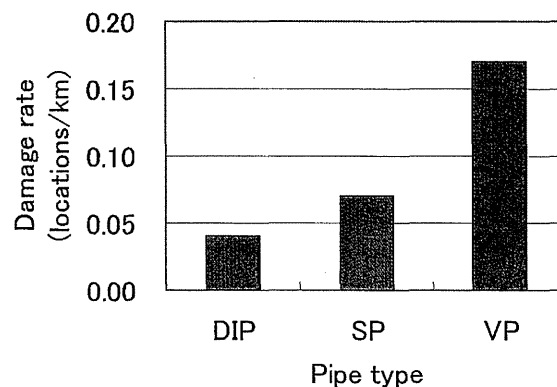
The total number of damage to transmission main, distribution main and branch pipelines was 264 except the flooded areas, and the piping length is 3,761km. The damage rate of transmission main, distribution main and branch pipelines was, therefore, 0.07 (locations/km). The damage rate in relation to pipe type and pipe diameter is shown in Fig. 1 and 2, respectively. Fig. 1 indicates that the damage rate of polyvinyl chloride pipe (VP) is high. Fig. 2 reveals that the smaller the pipe diameter is, the higher the damage rate.

Fig. 1 Damage rate related to pipe type.

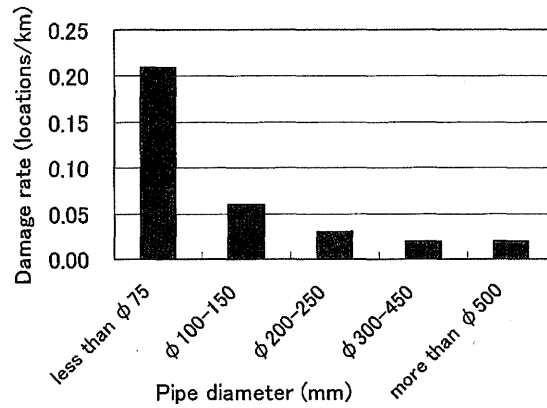
Fig. 2 Damage rate related to pipe diameter.

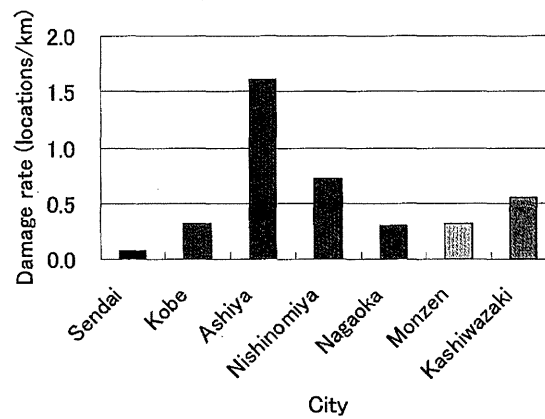
Fig. 3 Comparison of damage rate.

Fig. 3 illustrates a comparison of damage rate of Sendai City with those of other cities suffered damage to pipeline in the past earthquakes. Kobe, Ashiya and Nishinomiya Cities suffered damage to water supply pipeline in the 1995 Hyogo-ken Nambu Earthquake, Nagaoka City in the 2004 Niigata-ken Chuetsu Earthquake, Monzen Town in the 2007 Noto-hanto Earthquake and Kashiwazaki City in the 2007 Niigata-ken Chuetsu-oki Earthquake, respectively. This figure reveals that the damage rate of Sendai City was very low in comparison with another cities. Magnitude of earthquake and seismic intensity in each city were different. PGA of K-NET Sendai observation station was, however, not small; 1,808 (cm/s/s). This value is higher than most of cities listed in Fig. 3. One of reasons of low damage rate in Sendai City seems to be high earthquake-proofing rate. The earthquake-proofing rate is defined as the piping length of ductile cast iron pipe with earthquake resistant joint and welded steel pipe divided by the total piping length. The earthquake-proofing rate of Sendai City is 51.2%.

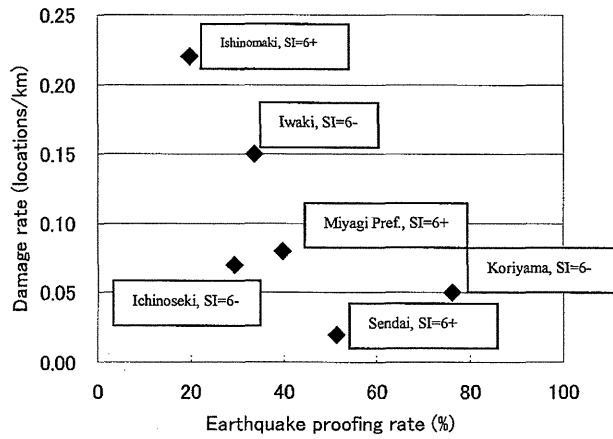
Fig. 4 illustrates the relation between the earthquake-proofing rate and damage rate suffered damage in the 2011 great east Japan earthquake. The damage rate shown in this figure is calculated by using the damage to transmission and distribution main pipeline, that is, distribution branch pipeline is not included. This figure indicates that the higher the earthquake-proofing rate, the lower the damage rate is. There was no damage to the ductile cast iron pipe with earthquake resistant joint. Effect of earthquake-proofing pipe was, therefore, verified by the earthquake.

Fig. 4 Relation between earthquake proofing rate and damage rate.

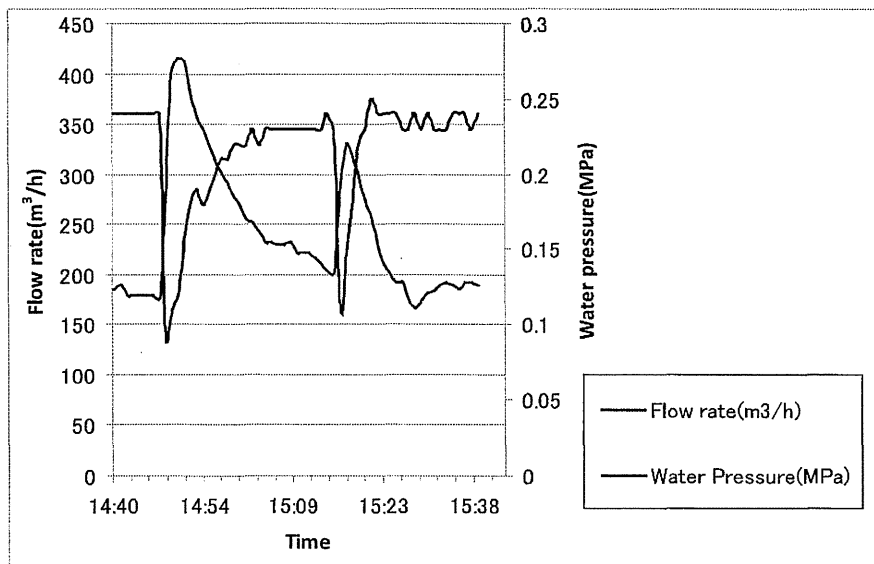
Unusual phenomena such as an abrupt increase in flow rate and a decrease in water pressure of water distribution system in spite of no damage to pipeline was occurred in several cities during the great east Japan earthquake. Fig. 5 shows time histories of the flow rate and water pressure at a water distribution plant of the Bureau of Waterworks Tokyo Metropolitan Government. The flow rate increased and water pressure decreased rapidly just after the earthquake. The higher flow rate and lower water pressure were recovered after about 20 minutes. The similar phenomena were occurred again by the aftershock.

Fig. 5 Time histories of the flow rate and water pressure at a water distribution plant of Tokyo.

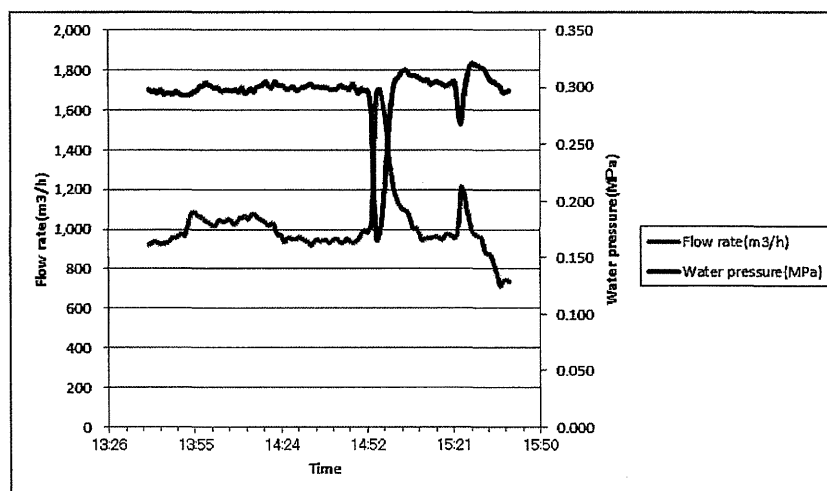
A questionnaire survey was conducted on the occurrence of the unusual phenomena of water distribution system after the great east Japan earthquake for twenty large scale waterworks bureaus not only in east Japan but also in west Japan. Table 1 lists the occurrence of the unusual phenomena of water distribution system in each waterworks bureau. The unusual phenomena occurred at even the cities where JMA seismic intensity was less than 5, that is, Yamagata, Nagoya and Osaka Cities. Fig. 6 shows time histories of the flow rate and water pressure at a water distribution plant of the Osaka City Waterworks Bureau. This figure shows that the similar phenomena of the Bureau of Waterworks Tokyo Metropolitan Government occurred in Osaka City where JMA seismic intensity was 3. It suggests that the unusual phenomena depend on not only magnitude of ground shaking but also other factors such as frequency characteristics of ground shaking.

Fig. 6 Time histories of the flow rate and water pressure at a water distribution plant of Osaka.

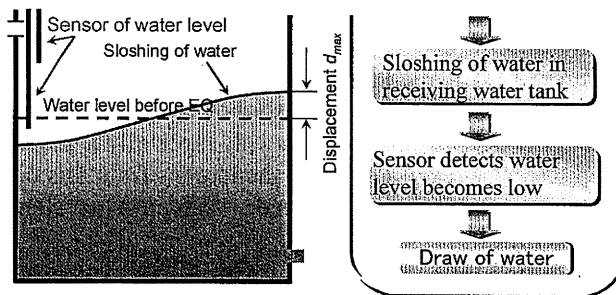
Fig. 8 Mechanism of draw of water from distribution pipe to receiving tank by sloshing during earthquake.

Murata and Miyajima³⁾ have considered that one of causes of the unusual phenomena seems to be sloshing of water in receiving water tank. If sloshing of water in receiving water tank is occurred by an earthquake, draw of water to receiving water tank starts by error of a sensor of water level in the receiving water tank as shown in Fig. 8. If sloshing of water in many receiving water tanks occurred simultaneously, an abrupt increase in flow rate and a decrease in water pressure may be occurred. Occurrence of sloshing of water in receiving water tank depends on the dimensions of receiving water tank and the height of water in the tank. Murata and Miyajima³⁾ have investigated dimensions of receiving water tank in a water distribution block of Osaka City and estimated the natural period of sloshing of the water. Fig. 9 shows cumulative percentage of natural period of water in receiving water tank in case that the height of water is 3/4 and 1/2 of the height of water tank. The height of water is variable and depends on use of water. The natural period of sloshing is more than 1.0 second

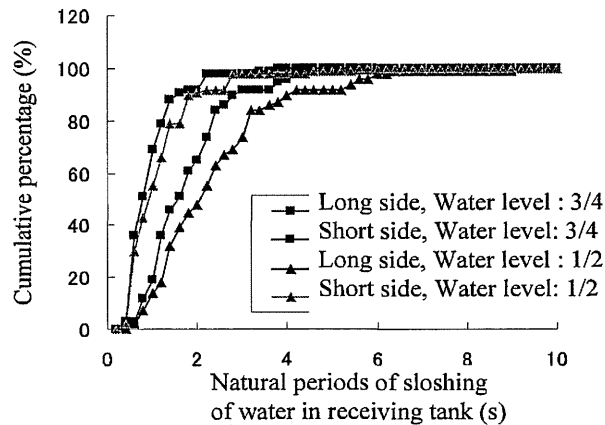
Fig. 9 Cumulative percentage of natural period of water in receiving water tank

of more than 80% of the water tank in the direction of long side in the water distribution block in Osaka City. This is one example, but long period ground motion more than one second can be caused sloshing of water in receiving water tank. However, the further study is needed to clarify the cause of an abrupt increase in flow rate and a decrease in water pressure of water distribution system in spite of no damage to pipeline and its effects to emergence response just after large scale disaster.

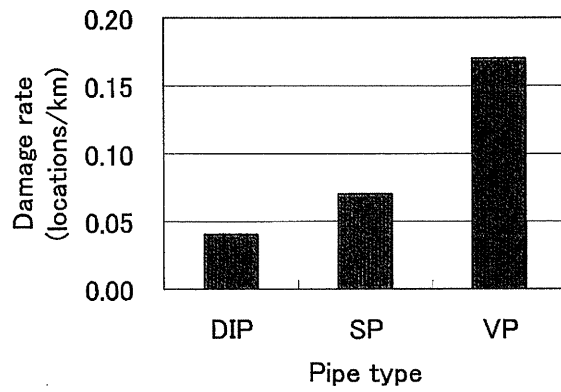
The total number of damage to transmission main, distribution main and branch pipelines was 264 except the flooded areas, and the piping length is 3,761km. The damage rate of transmission main, distribution main and branch pipelines was, therefore, 0.07 (locations/km). The damage rate in relation to pipe type and pipe diameter is shown in Figs. 1 and 2, respectively. Fig. 1 indicates that the damage rate of polyvinyl chloride pipe (VP) is high. Fig. 2 reveals that the smaller the pipe diameter is, the higher the damage rate.

Figure 1 Damage rate related to pipe type.

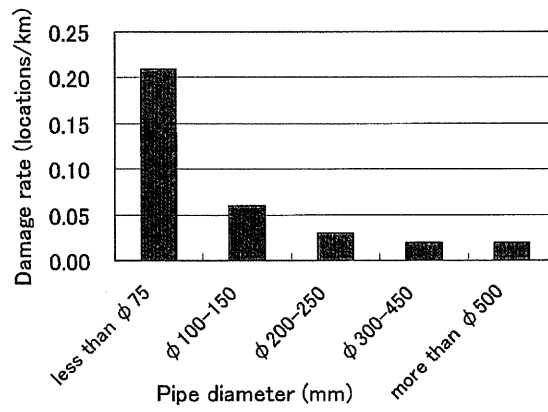
Figure 2 Damage rate related to pipe diameter.

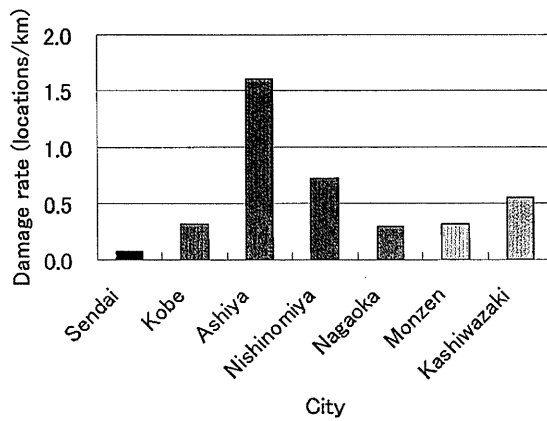
Fig. 3 illustrates a comparison of damage rate of Sendai City with those of other cities suffered damage to pipeline in the past earthquakes in Japan. Kobe, Ashiya and Nishinomiya Cities suffered damage to water supply pipeline in the 1995 Hyogo-ken Nambu Earthquake, Nagaoka City in the 2004 Niigata-ken Chuetsu Earthquake, Monzen Town in the 2007 Noto-hanto Earthquake and Kashiwazaki City in the 2007 Niigata-ken Chuetsu-oki Earthquake, respectively. This figure reveals that the damage rate of Sendai City was very low in comparison with another cities. Magnitude of earthquake and seismic intensity in each city were different. PGA of K-NET Sendai observation station was, however, not small; 1,808 (cm/s/s). This value is higher than most of cities listed in Fig. 3. One of reasons of low damage rate in Sendai City seems to be high earthquake-proofing rate. The earthquake-proofing rate is defined as the piping length of ductile cast iron pipe with earthquake resistant joint and welded steel pipe divided by the total piping length. The earthquake-proofing rate of Sendai City is 51.2%.

Figure 3 Comparison of damage rate.

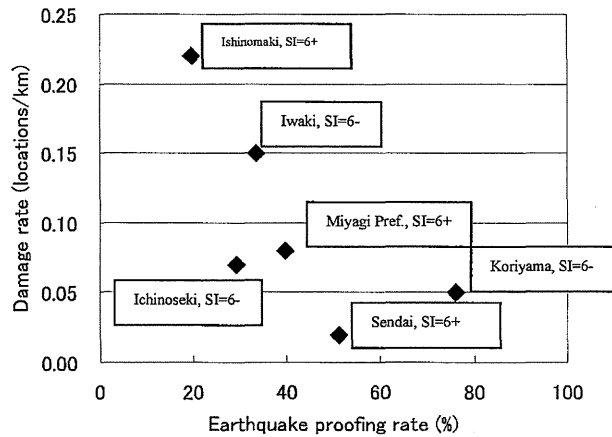
Fig. 4 illustrates the relation between the earthquake-proofing rate and damage rate of each waterworks bureau suffered damage in the 2011 great east Japan earthquake. The damage rate shown in this figure is calculated by using the damage to transmission and distribution main pipeline, that is, distribution branch pipeline is not included. This figure shows JMA (Japan Meteorological Agency) seismic intensity scale in each area. This figure indicates that the higher the earthquake-proofing rate, the lower the damage rate is. There was no damage to the ductile cast iron pipe with earthquake resistant joint. Effect of earthquake-proofing pipe was, therefore, verified by the earthquake.

Figure 4 Relation between earthquake proofing rate and damage rate.

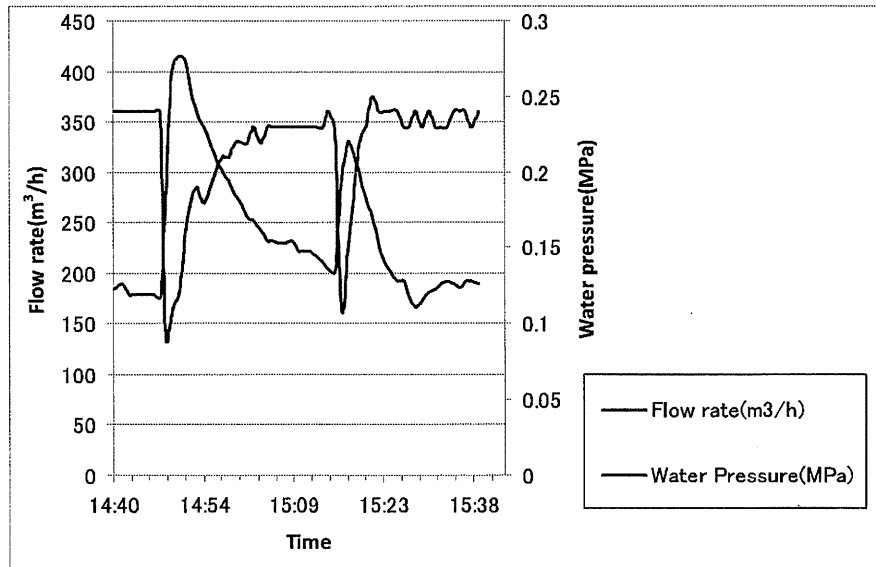
Unusual phenomena such as an abrupt increase in flow rate and a decrease in water pressure of water distribution system in spite of no damage to pipeline was occurred in several cities during the great east Japan earthquake. Fig. 5 shows time histories of the flow rate and water pressure at a water distribution plant of the Bureau of Waterworks Tokyo Metropolitan Government. The flow rate increased and water pressure decreased rapidly just after the earthquake. The higher flow rate and lower water pressure were recovered after about 20 minutes. The similar phenomena were occurred again by the aftershock.

Figure 5 Time histories of the flow rate and water pressure at a water distribution plant of Tokyo.

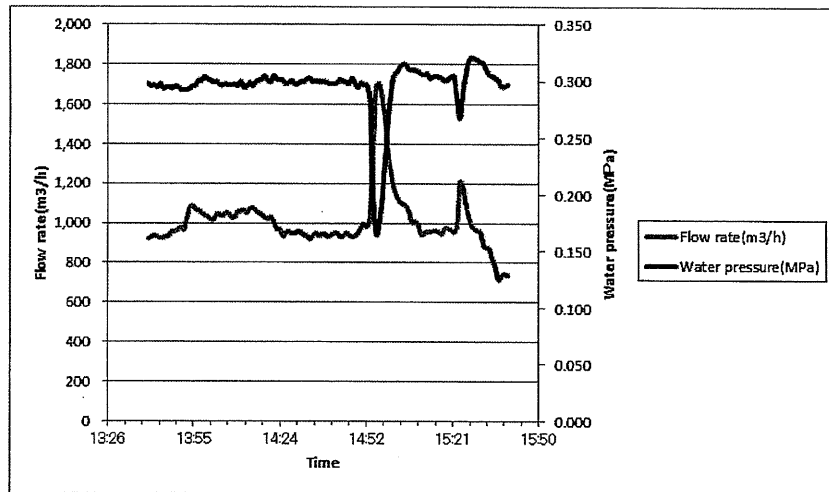
A questionnaire survey was conducted on the occurrence of the unusual phenomena of water distribution system after the great east Japan earthquake for twenty large scale waterworks bureaus not only in east Japan but also in west Japan. Table 1 lists the occurrence of the unusual phenomena of water distribution system in each waterworks bureau. The unusual phenomena occurred at even in the cities where JMA seismic intensity scale was less than 5, that is, Yamagata, Nagoya and Osaka Cities. Fig. 6 shows time histories of the flow rate and water pressure at a water distribution plant of the Osaka City Waterworks Bureau. This figure shows that the similar phenomena of the Bureau of Waterworks Tokyo Metropolitan Government occurred in Osaka City where JMA seismic intensity scale was 3. It suggests that the unusual phenomena depend on not only magnitude of ground shaking but also other factors such as frequency characteristics of ground shaking.

Figure 6 Time histories of the flow rate and water pressure at a water distribution plant of Osaka.
