# 2011年東日本大震災における水道施設の 地震被害の特徴

## CHARACTERISTICS OF DAMAGE TO WATER SUPPLY FACILITIES IN THE 2011 GREAT EAST JAPAN EARTHQUAKE

# Damage to Water Supply Facilities during the 2011 Great East Japan Earthquake and Tsunami

Masakatsu Miyajima (School of Environmental Design, Kanazawa University, Japan)

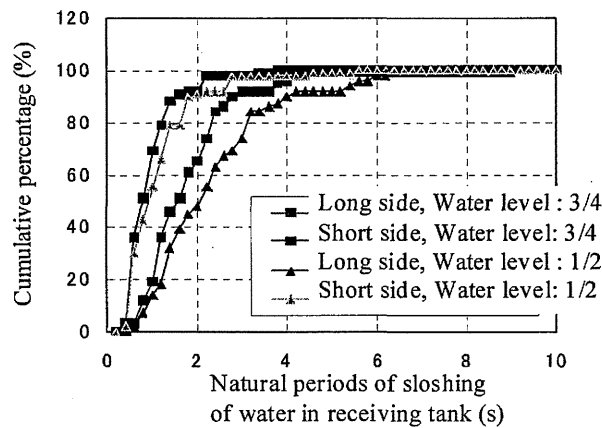
**Figure 9** Cumulative percentage of natural period of water in receiving water tank

Murata and Miyajima have considered that one of the causes of the unusual phenomena seems to be sloshing of water in receiving water tank. If sloshing of water in receiving water tank is occurred by an earthquake, draw of water to receiving water tank from a distribution pipelines starts by error of a sensor of water level in the receiving water tank as shown in Fig. 8. If sloshing of water in many receiving water tanks occurred simultaneously, an abrupt increase in flow rate and a decrease in water pressure in the distribution pipeline may be occurred. Occurrence of sloshing of water in receiving water tank depends on the dimensions of receiving water tank and the height of water in the tank. Murata and Miyajima have investigated dimensions of receiving water tank in a water distribution block of Osaka City and estimated the natural period of sloshing of the water. Fig. 9 shows cumulative percentage of natural period of water in receiving water tank in case that the height of water is 3/4 and 1/2 of the height of water tank. The height of water is variable and depends on use of water. The natural period of sloshing is more than 1.0 second of more than 80% of the water tank in the direction of long side in the water distribution block in Osaka City. This is one example, but long period ground motion more than one second can be caused sloshing of water in receiving water tank. However, the further study is needed to clarify the cause of an abrupt increase in flow rate and a decrease in water pressure of water distribution system in spite of no damage to pipeline and its effects to emergence response just after large scale disaster.

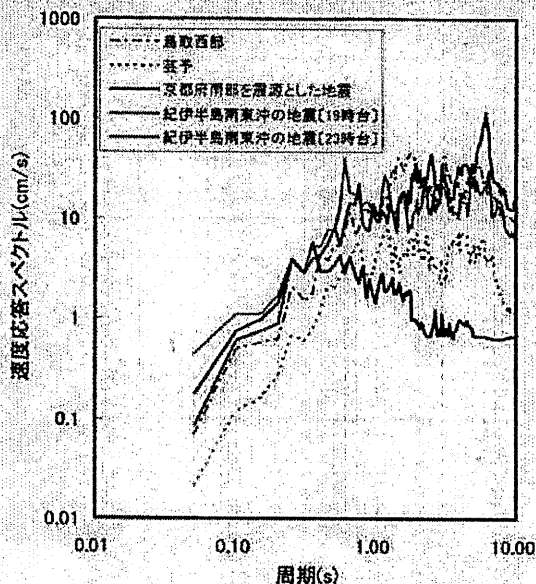
図4 各地震における速度応答スペクトル  
以上の変位が発生しており、最大変位についても

は、地震動の強さだけでなく、地震動の振動特性も寄与しているのではないかと考えられる。そこで、表1で挙げられている各地震の速度応答スペクトルに注目した。図4に各地震の速度応答スペクトルを示す。異常挙動の発生が確認されている鳥取県西部地震、芸予地震および紀伊半島南東沖の地震において、1秒以上のやや長周期の振動成分が卓越している。一方、異常挙動の発生が確認されなかった京都府南部を震源とする地震については、1秒以下の振動成分が卓越しており、他の地震に比べ卓越周期帯が短いことが明らかとなった。これらの速度応答スペクトルから、地震発生直後に発生する水道供給システムの異常挙動は、ある周期の地震動、すなわちやや長周期の地震動が間接的に水供給システムに影響を及ぼしていると推測される。

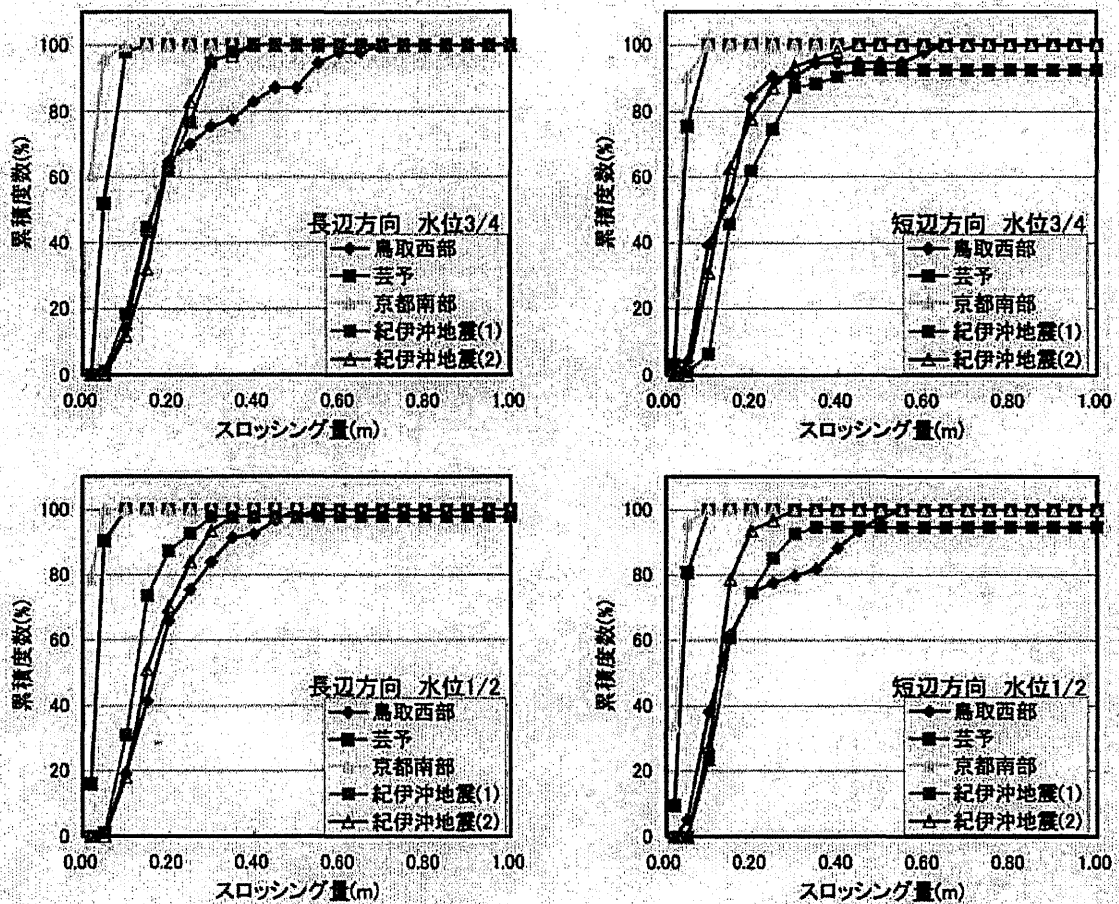
図5各地震におけるスロッシング量

受水槽は内部の水が一定水位以下になると、近傍の配水管から引水する構造になっている。したがって、地震時にスロッシングが発生すると、水面が一時的に低下し、一斉に引水をはじめることにより、異常挙動が発生したと考えることができる。そこで、表1に示した各地震の大阪市における観測記録を用いてスロッシング変位量を計算した<sup>1)</sup>。図5は、大阪市咲洲地区において行った受水層の実態調査に基づいて集計した各受水槽について、Housnerの計算式<sup>2)</sup>を用いて計算したスロッシング量を累積度数で示した図である。解析結果から明らかのように、芸予地震を除き、異常挙動が発生した鳥取県西部地震、紀伊半島南東沖の地震は、受水槽の有効水位の1/2の時に約半数以上で0.1m

0.5m を超える変位が発生する。一方、異常挙動が確認出来なかった京都府南部を震源とした地震では、異常挙動が確認できた芸予地震よりもスロッシング量が低く、90%以上が0.05m 以下のスロッシング量となっており、ほとんどの受水槽において、地震によるスロッシングが発生しないという。このことから、やや長周期の地震動による受水槽のスロッシング現象が水供給システムの異常挙動に深く関与していることがわかる。
