Lessons from the 2011 Great East Japan Earthquake and Tsunami Disasters

M. Miyajima*

This paper deals with an outline of damage induced by the 2011 great east Japan earthquake and tsunami. An earthquake with a magnitude of 9.0 occurred off the coast of northeast Japan on March 11, 2011 at 14:46 on local time. The earthquake generated a tsunami of unprecedented height and special extent along the coast of the main island of Japan. The earthquake and tsunami caused about 20,000 deaths and missing and injured about 6,000 people. A suspension of water supply was also occurred at about 2,300,000 houses in east Japan just after the earthquake. An outline of damage to water supply facilities is given and lessons learned from the earthquake and tsunami is discussed.

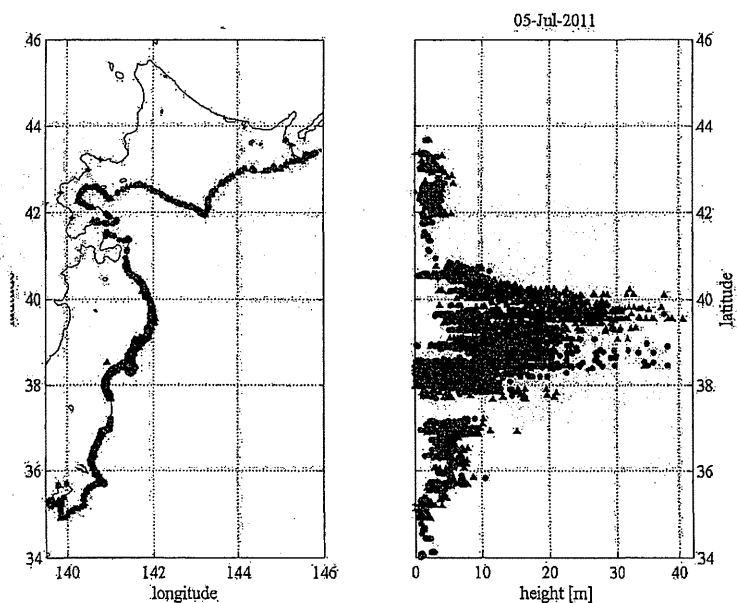
Figure 4 Inundation and run up heights of tsunami³⁾.
(red circle: inundation height, blue circle; run-up height)

Figure 4 shows inundation and run-up heights in Hokkaido, Tohoku and Kanto regions surveyed by Tohoku Earthquake Tsunami Joint Survey Group³⁾. Tsunami terminology is given by Figure 5⁴⁾. According to their survey, the maximum run-up height was 39.7m at Miyako City. The maximum inundation height at the Sendai Plain was 19.5m and the mean inundation height near the shoreline was about 10m⁴⁾. It has been estimated from areal and satellite photography that almost 535 km² of land were inundated in according to the Ministry of Land, Infrastructure, Transport and Tourism⁵⁾. The tremendous tsunami caused a catastrophic destruction in Tohoku region.

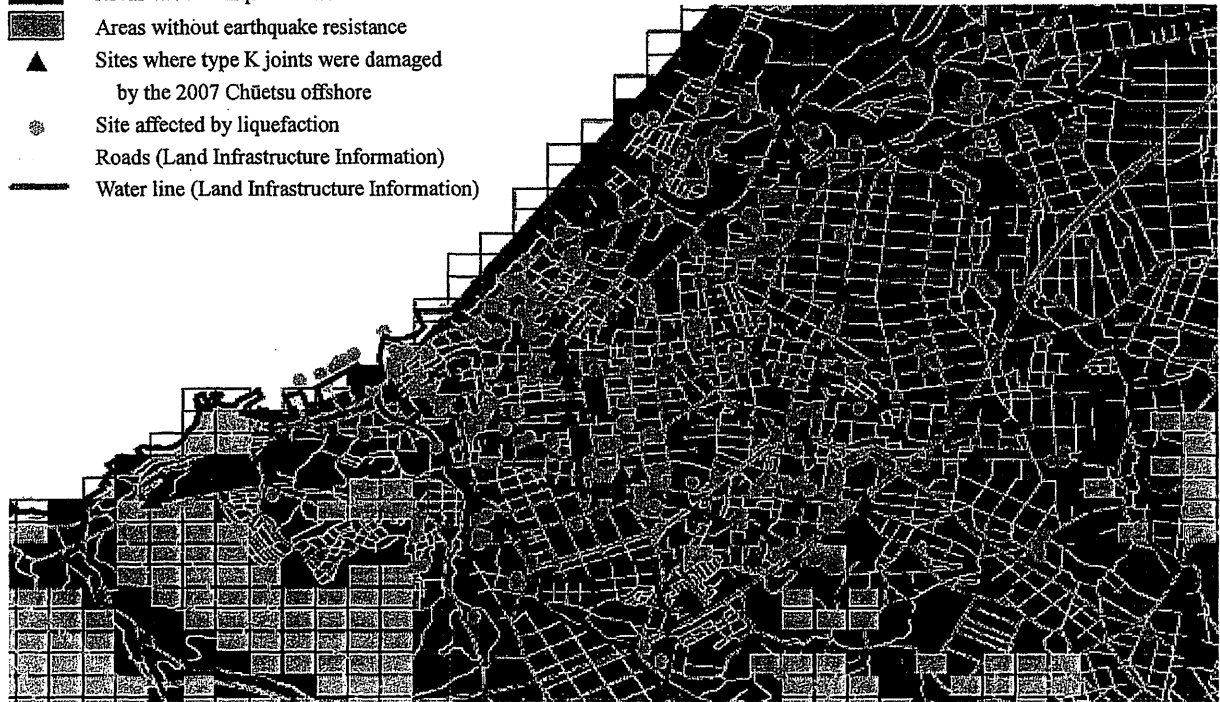
Fig. 7: Judgment of ground conditions based on method 2

The judgment achieved by method 2 and the actual location of water pipeline damage that occurred as a result of the 2007 Chūetsu offshore earthquake are overlaid for comparison in Fig. 7. The bulk of the damage caused by the earthquake occurred in the areas judged as having no earthquake resistance. Thus, method 2 has high accuracy and high validity. Judgment method 2 using the J-SHIS data achieved a similar validity.
