### Ⅲ. 研究成果の刊行に関する一覧表

# 高濁度原水における二段凝集処理 最適化の検討

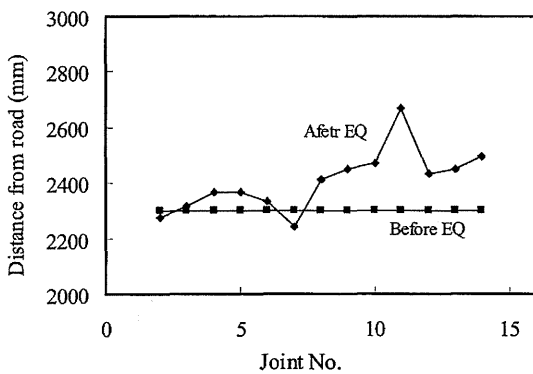
**Figure 2** | Distance to the pipeline from a road edge before and after the earthquake.

Figure 2 illustrates a horizontal distance to a pipeline from the edge of a road before and after the earthquake. Because the road was not dislocated horizontally or deformed by the earthquake and tsunami, this figure indicates that the pipeline moved about 40 cm. Figure 3 shows the bending angles at joints measured at the field. The maximum bending angle is 7.5 degrees at the joint No. 11. It seems that the pipeline was exposed above ground by the scouring, hit by a steel container and debris in undertow of the tsunami, and moved to the coastline. There was, however, no damage to ERDIP and water suspension did not occur.

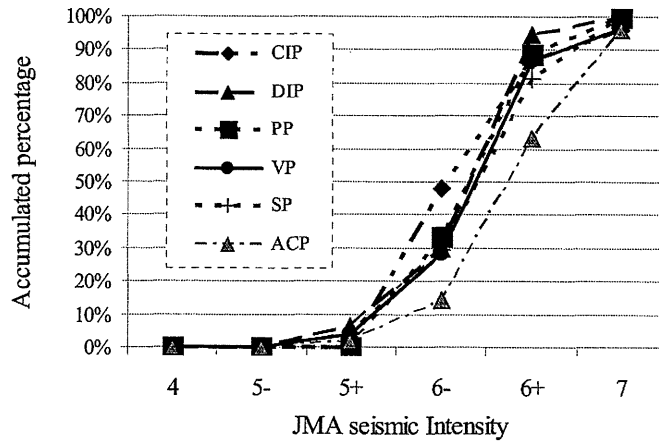
**Figure 5** | Accumulated damage rate of each pipe type.

The main types of buried water pipes in Japan are ductile cast iron pipes (DIP), grey cast iron pipes (CIP), steel pipes (SP), polyethylene pipes (PE), polyvinyl chloride pipes (PVC), and asbestos cement pipes (ACP). Figure 5 illustrates an accumulated damage rate of each pipe type. This figure indicates that the damage to pipeline starts to occur at 5+ of JMA seismic intensity and the damage rapidly increases at 6+.

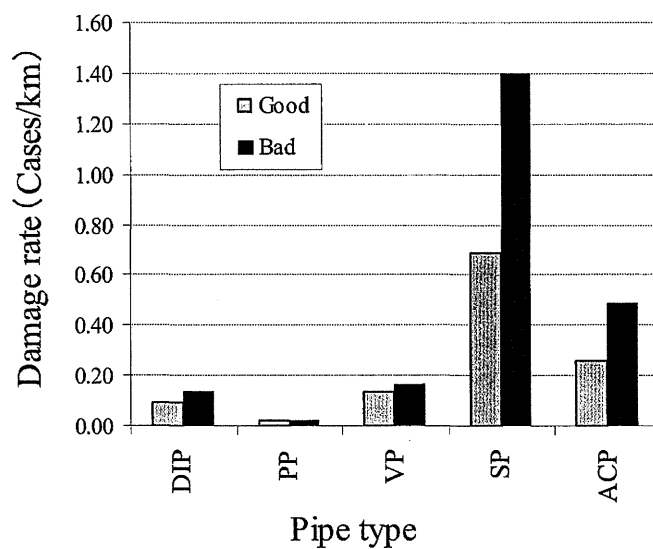
**Figure 7 |** Comparison of damage rate of each pipe type in micro topography classification category.

Figure 7 illustrates a comparison of damage rate by pipe type in the two micro topography classification categories. This figure suggests that the damage rates in Bad are much greater than those in Good.

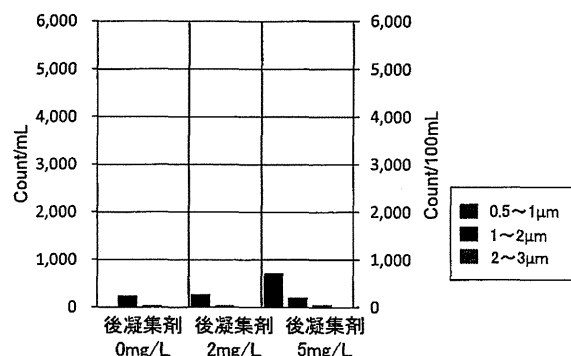
図5 原水濁度50度における超高塩基度PACI使用時の砂ろ過水の微粒子数

原水濁度50度における両凝集剤を使用した際の砂ろ過水の粒径別粒子数を図2および図3に示す。尚、粒子数の単位は粒子径0.5~1 $\mu$ mがCount/mL、粒子径1~2 $\mu$ m、2~3 $\mu$ mがCount/100mLである。この際の沈殿水濁度は通常PACIでは3.2~3.7度、超高塩基度PACIでは2.8~3.4度であり、大きな差は認められなかった。また、原水濁度100度における両凝集剤を使用した際の砂ろ過水の粒径別粒子数を図5および図6に示す。この際の沈殿水濁度は通常PACIで5.0~6.7度、超高塩基度PACIで4.2~4.8度であり、原水濁度50度の場合と比較すると凝集剤による違いが認められた。図2、3より原水濁度が50度場合、沈殿水濁度がほぼ同じにも関わらず、後段凝集に用いる凝集剤の違いにより、特に粒子径0.5~1 $\mu$ mの粒子数に大きな違いが認められた。また、凝集剤の注入率によっても粒子径0.5~1 $\mu$ mの粒子数に違いが認められ、凝集剤の種類、注入率を最適化することでより清澄な砂ろ過水を得られることが示された。

図4、5より原水濁度が100度の場合、どちらの凝集剤を使用した場合でも注入率が高い実験条件で粒子径0.5~1 $\mu$ mの粒子数の増加が見られた。図4に示した後段凝集剤注入率が5mg/Lの際の砂ろ過損失水頭は実験期間で約6.7kPa増加していたことから破過の前兆であると考えられる。比較的高い濁度でも二段凝集は砂ろ過水の濁質低減に有用な方法ではあるが、注入率が高い場合には破過を起し、砂ろ過水の水質が低下する可能性があることが示された。

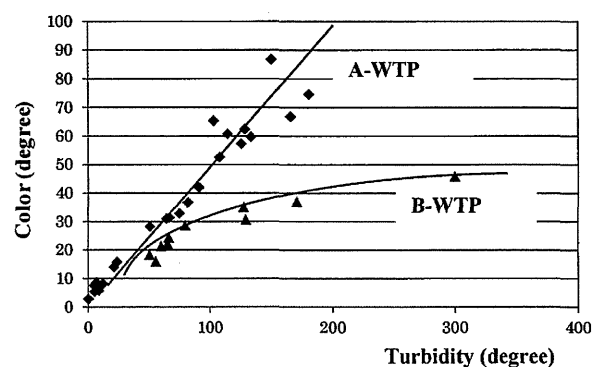
**Figure 2.** Correlation between color and turbidity of raw water

*Behavior of color during high turbidity and the coagulant dose for color.* Figure 2 shows a correlation between color and turbidity during high turbidity periods at A and B WTPs, which use raw water sources of high color originated from peat. As is shown in the figure, the color increases with the increase in turbidity, meaning it would be more difficult to control coagulation and sedimentation processes for high turbidity raw water due to higher coagulant consumption caused by color.
