## **Damage to Water Supply Pipelines in the 2011 Great East Japan Earthquake**

This paper is focusing on damage to water supply pipelines during the 2011 great east Japan Earthquake. Severe damages were occurred not only to houses and buildings but also lifeline facilities including water supply facilities by this earthquake and tsunami. Water supply pipelines were damaged by strong ground motion and/or soil liquefaction. Outline of the damage is given first. Then the damage analysis is done by using GIS database of water supply pipelines and its damage. Lessons learned regarding the earthquake performance of water supply pipeline are summarized.

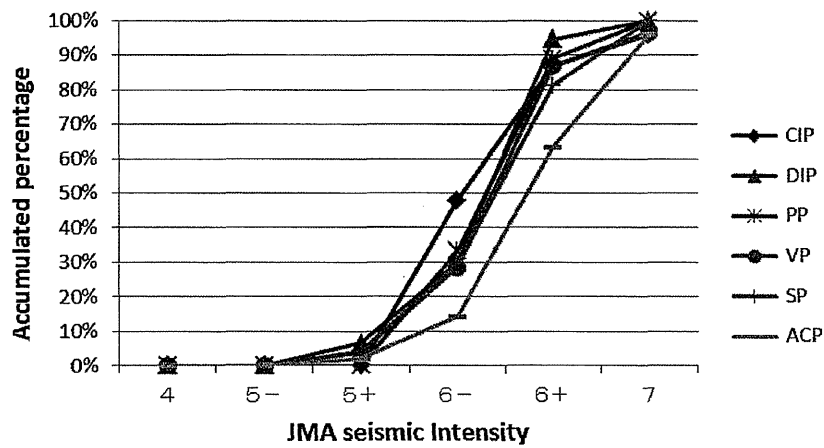
Figure 4 indicates that the damage to pipeline starts to occur at 5+ of JMA seismic intensity and the damage rapidly increases at 6+.

Figure 4. Accumulated damage rate of each pipe type.

Maximum JMA seismic intensity of this earthquake was 7 in Kurihara City and the JMA seismic intensity in the surrounding cities and a town of Kurihara City was 6+. The damage to buried pipeline in Kurihara City and the surrounding cities and town, that is, Osaki City, Tome City and Wakuya Town is discussed here. Figure 3 illustrates distribution of JMA seismic intensity estimated by QuakeMap (National Institute of Advanced Industrial Science and Technology) and sites of damage to each pipe type of water supply pipeline in three cities and a town mentioned above. JMA seismic intensity estimated by QuakeMap is given in each 250 m cell. Table 2 lists a number of cells in each level of JMA seismic intensity of three cities and a town. 7.6% of the total area is 7 of JMA seismic intensity and 33.6% is 6+, 23.8% is 6- according to QuakeMap. Figure 4 illustrates an accumulated damage rate of each pipe type.

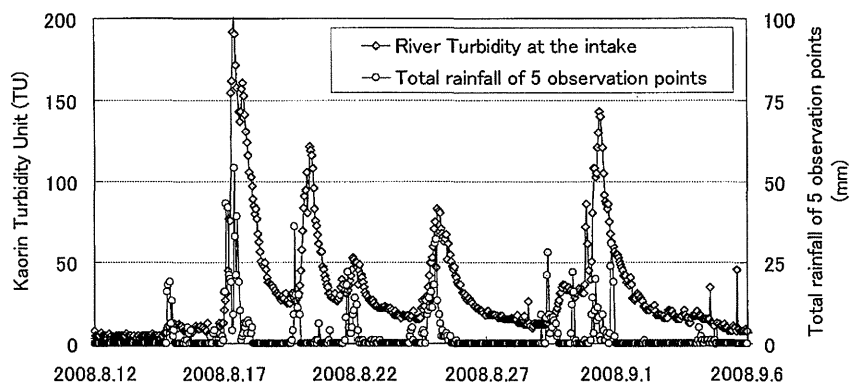
Figure 1.2 illustrates the upstream rainfall of the intake point and the raw water turbidity, taking the time difference of their occurrences into consideration. It shows that the turbidity tends to increase as the total upstream rainfall goes up. The same tendency is also seen in the relation between the river flow and the turbidity while their relational patterns can be classified into four different groups (Figure 1.3). This might be due to regional and seasonal characteristics of rainfall, precipitation, and past history of rainfall. A positive correlation was similarly found between the water level and the turbidity. These observations indicate a possibility to predict raw water turbidity from upstream river information: rainfall, river flow and water level. Below is an example of a prediction equation based on upstream river flow:

Figure 1.2 Relation of turbidity and rainfall

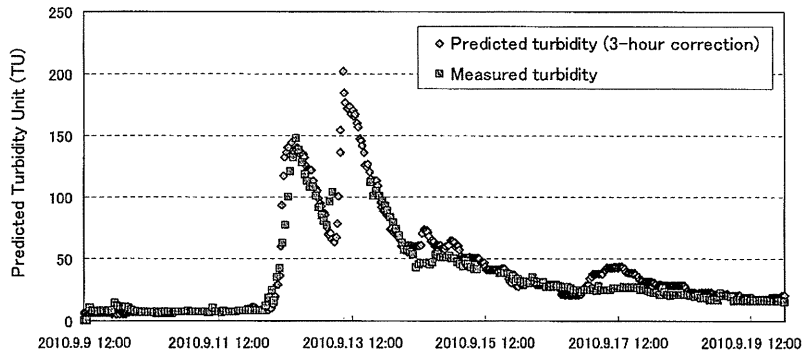
Figure 1.4 shows two kinds of turbidities: one was calculated by the equation and the other from actual measurement (with their time lags corrected). The two turbidities display almost the same tendency, demonstrating that it is possible to predict raw water turbidity from upstream river flow.

**Figure 1.4 Result of turbidity prediction**

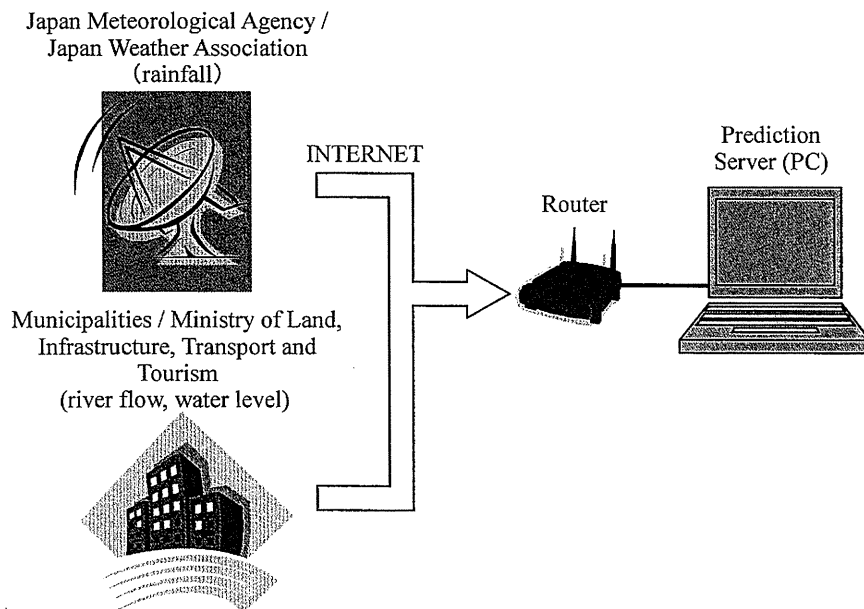
Encouraged by this result, we developed the software programme to predict raw water turbidity. Figure 1.5 represents its schematic picture. From the Internet, it collects publicized information of target river system such as rainfall, river flow and water level in order to calculate arriving time of high-turbidity water at water intake point, its peak turbidity and duration. On the screen, the server displays the latest information of the river system including rainfall, river flow and water level; each datum is updated automatically as it fluctuates.

**Figure 1.5 Overview of prediction model**
