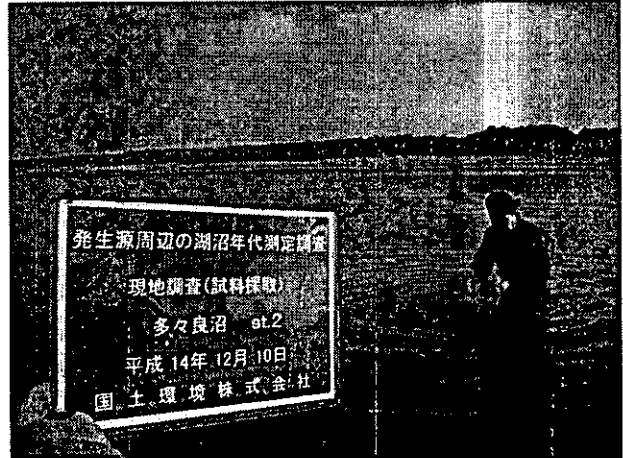
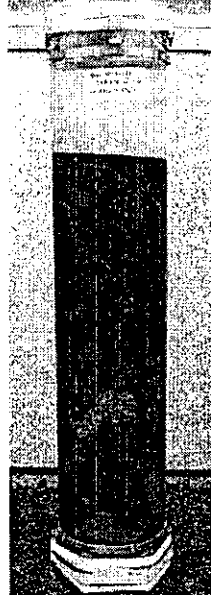
図 3.2 現地調査・コア観察記録 (St. 2)

(1) 現地調査

(2) コア 1

(3) コア 2

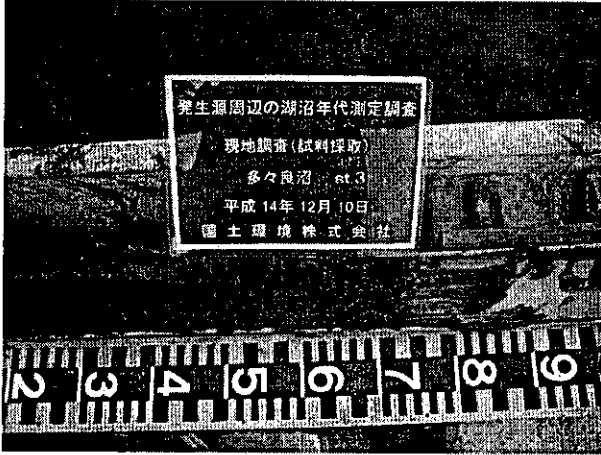
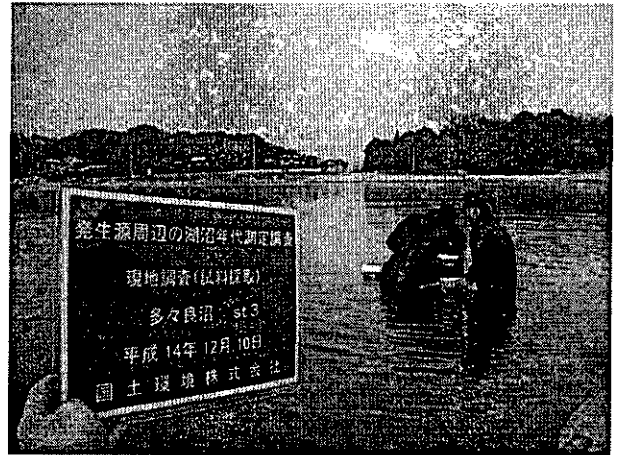
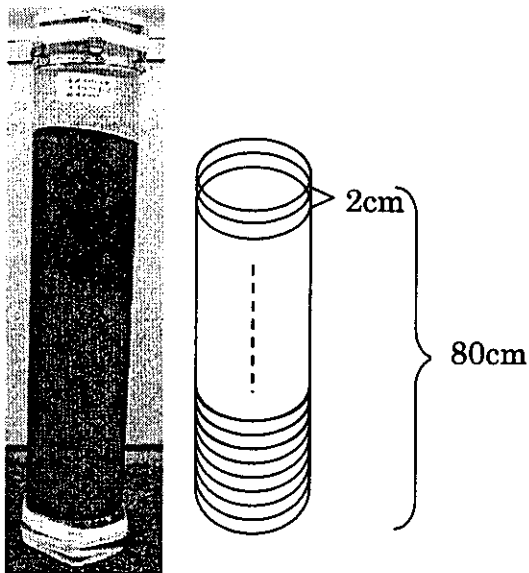
図 3.3 現地調査・コア観察記録 (St.3)

(1) 現地調査

(2) コア 1

(3) コア 2
